## 1.4 Analysis of the interaction of groups of buildings within the boundaries of dense building

With the participation of the author, work was carried out on the technical inspection of buildings on Olena Stepanivna street in Lviv. The work was carried out in order to determine its actual technical condition and, if necessary, to provide recommendations on the elimination of identified deficiencies.

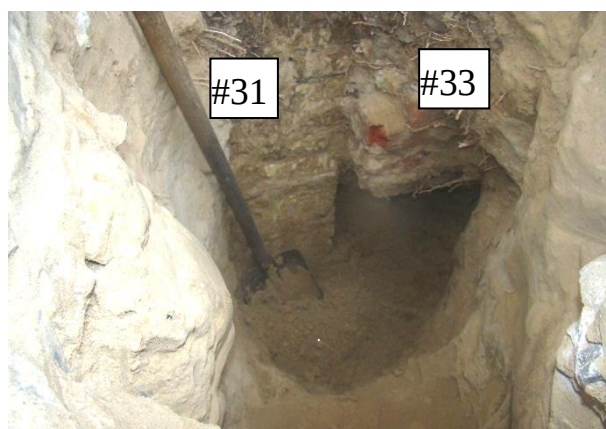
Overloading of foundations under the foundation of the load-bearing wall along axis "5" of building #31 and its increased subsidence caused by additional loading of the base of the foundation of building #33, which is located along this same axis "5" and lies 0,5 m above the base of the foundation along axis "5" building #31 (Fig. 3, 4). The soles of the foundations of building #33 along axis "1" are located in the backfill of the foundation along axis "5" of building #31, which was built 3 years earlier.

Figure 3. The sole of the foundation of building #31 is located 0,5 m below the sole of the foundation of building #33

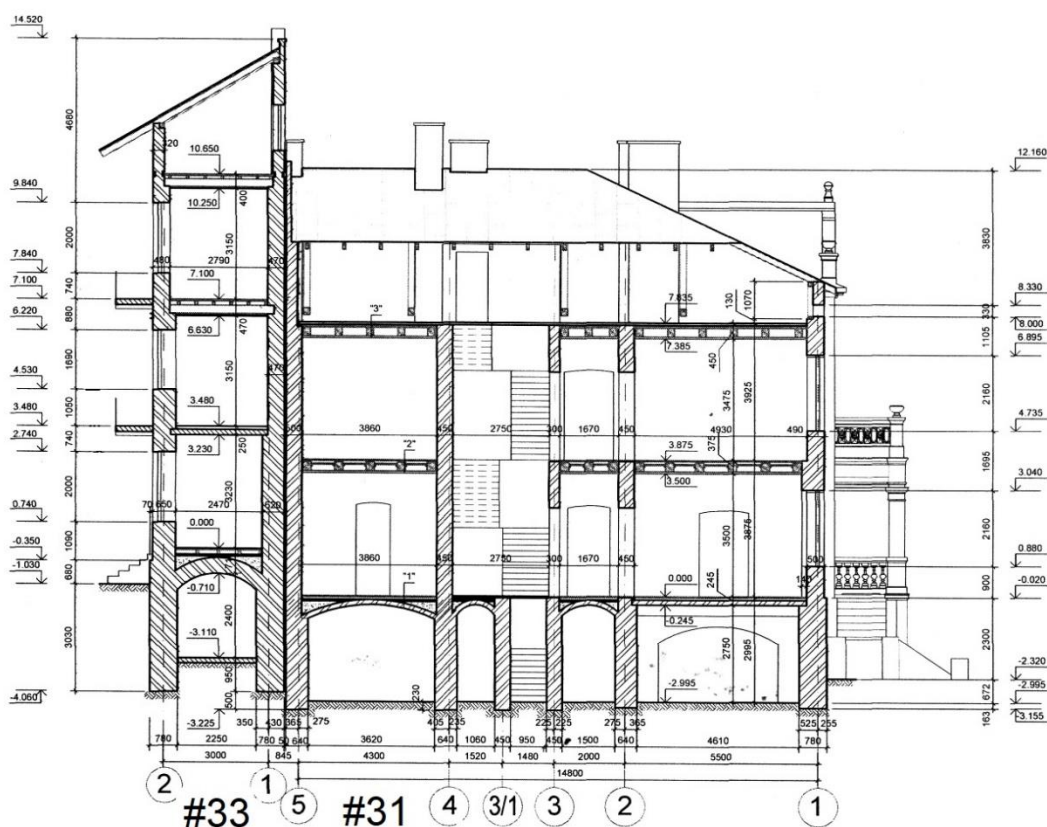
Figure 4. Cross section of buildings #33 and #31

During the inspection, it was determined that, first of all, the formation of cracks in the wall of building #33 should be considered as a consequence of the unsatisfactory operation of the drainage system in the building itself and from its yard. Rainwater

easily seeps into the sandy soils of the foundation, creating problems both in the foundations of building #33 itself and in the adjacent building #31.

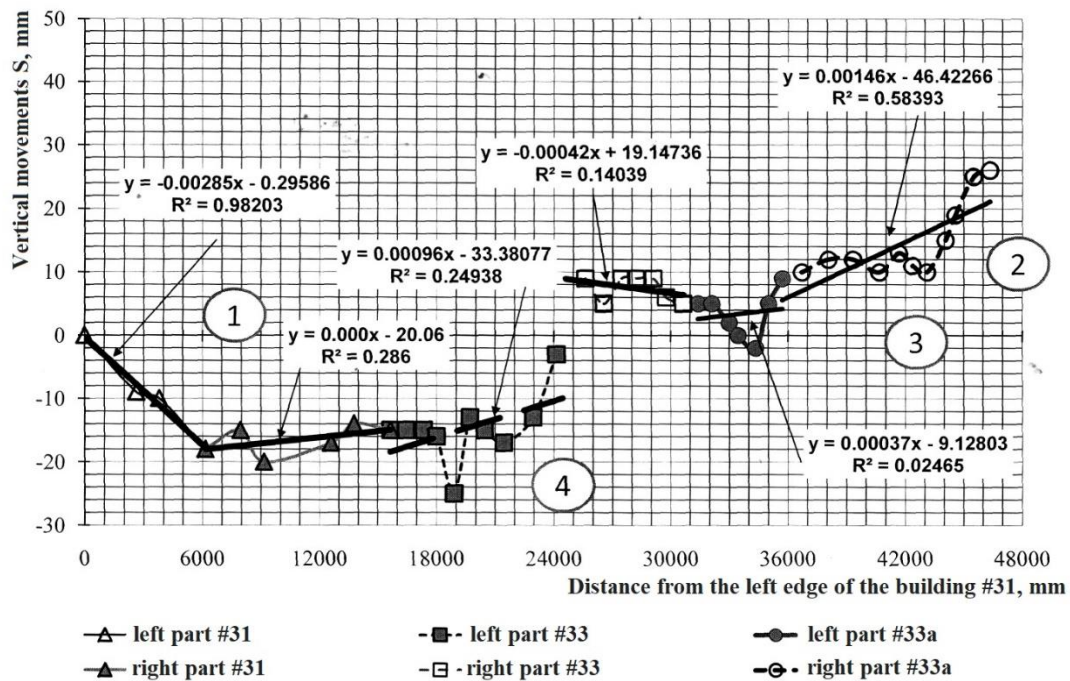
Figure 5. The nature of the distribution of measurements of vertical deformations along the lengths of the front walls of four buildings #31 (1), #33 (4), #33a (3) and #33b (2) (numbers 1-4 – construction sequence). Integral distribution of deformations obtained by approximating experimental data with linear equations

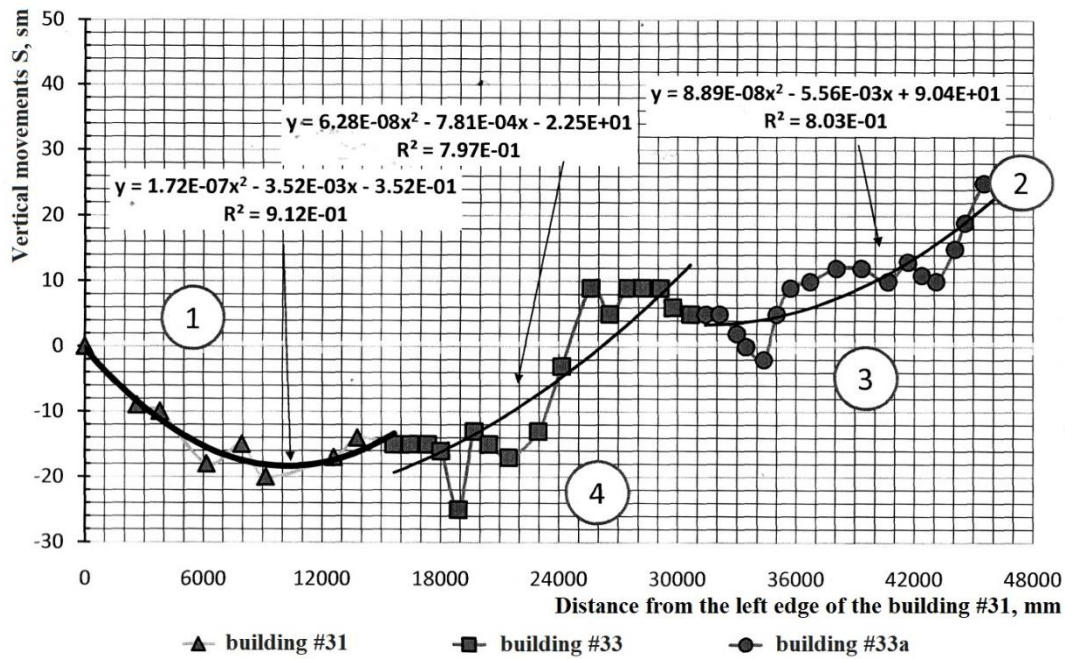
Figure 6. Distribution of vertical deformations along the length of the front walls of three buildings ##31, 33, 33a. Integral regularities of their distribution obtained by approximating the measured data by polynomial equations of the second degree

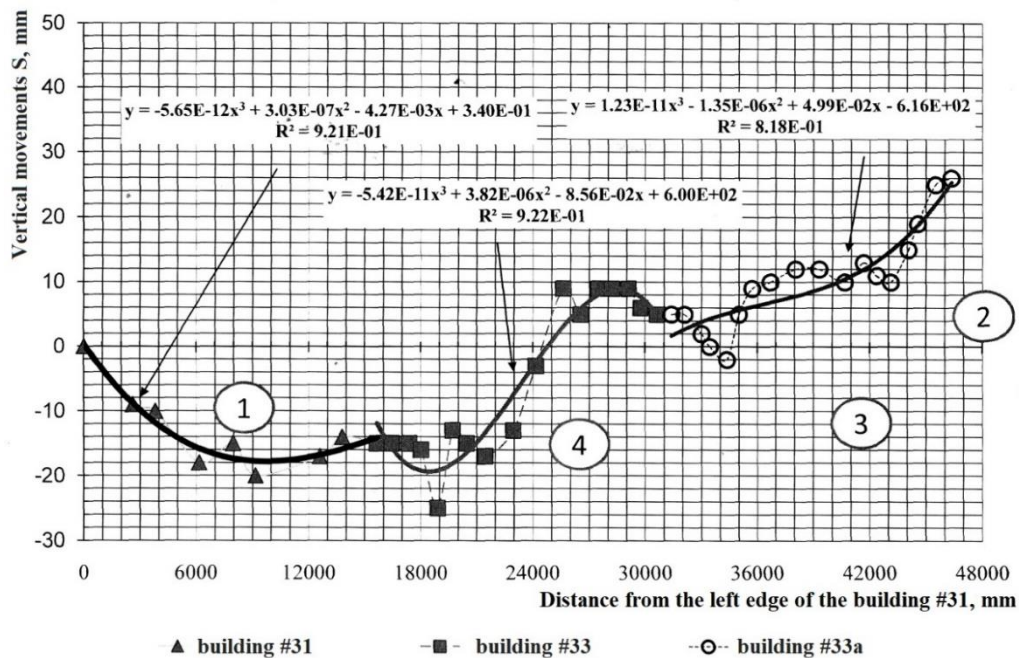
Figure 7. Distribution of vertical deformations along the length of the front walls of three buildings ##31, 33, 33a. Integral regularities of their distribution obtained by approximating the measured data by polynomial equations of the third degree

The analysis of these directions and their actual values showed that in the process of operation and successive additions of new buildings to the existing #31, unfounded decisions were made at the time of construction from the point of view of the mutual influence of the additions and adjacent existing buildings.

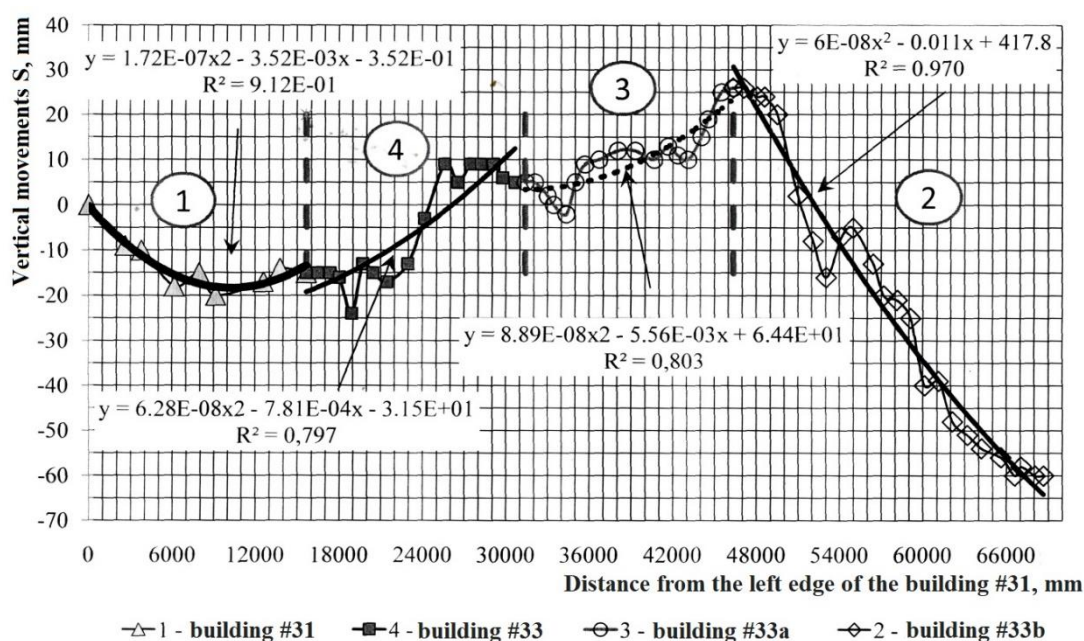
Figure 9. The nature of vertical deformations along the length of the facade walls and the construction sequence of four buildings: 1 - #31; 2 - #33b; 3 - #33a; 4 - #33. The integral distribution of deformations is obtained by approximating the experimental data with equations of the second degree

Approximation by linear equations of vertical deformations of sections of facades of four buildings ##31, 33, 33a, 33b made it possible to determine the roll of each section, the values of which are shown in figure 9.

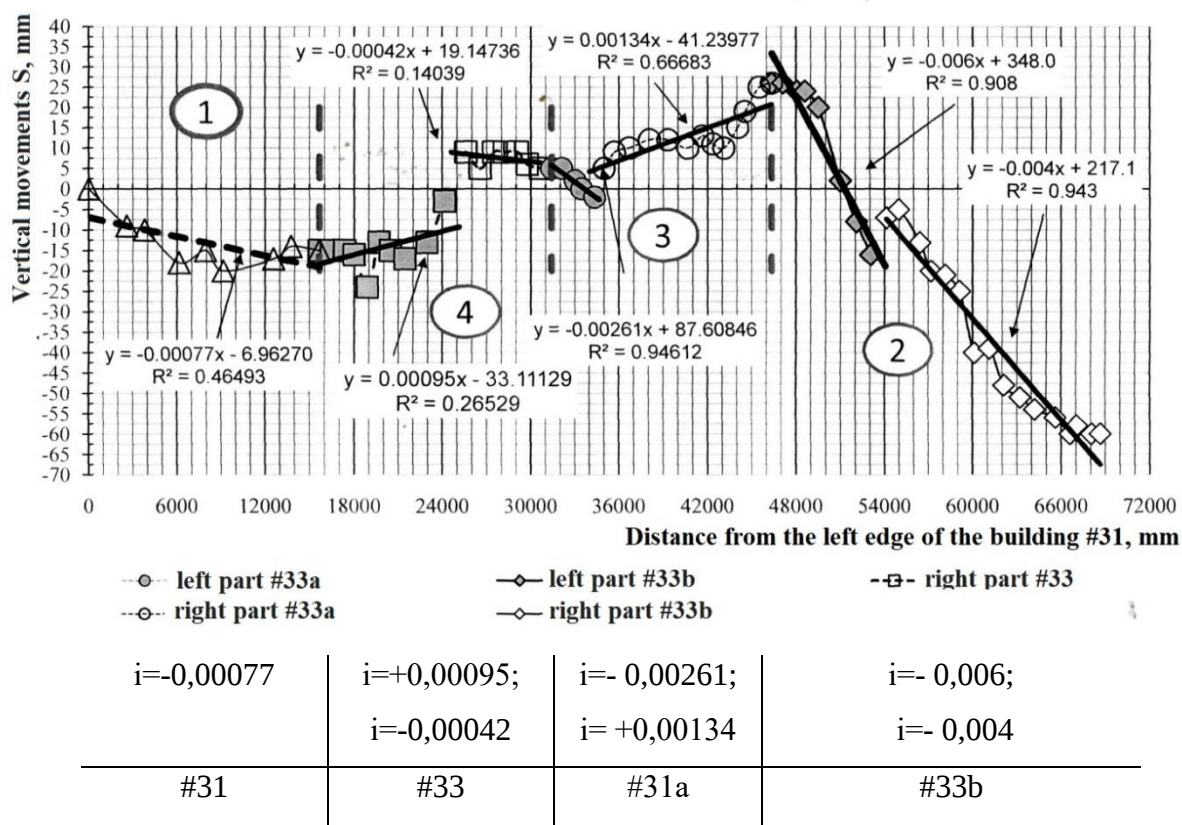
Figure 10. Approximation by linear equations of vertical deformations of characteristic areas on the walls of the main facades of four buildings ##31, 33, 33a, 33b to determine their slopes
