### **1.9 Preservation and restoration of building structures of churches in Ukraine, which are religious, historical, cultural and architectural heritage**

Survey and fortification of the bell tower in the village. Hlibovychi, Lviv region, Ukraine.

Inspection of the Church of the Intercession of the Holy Virgin in the village of Svirzh, Lviv region, Ukraine.

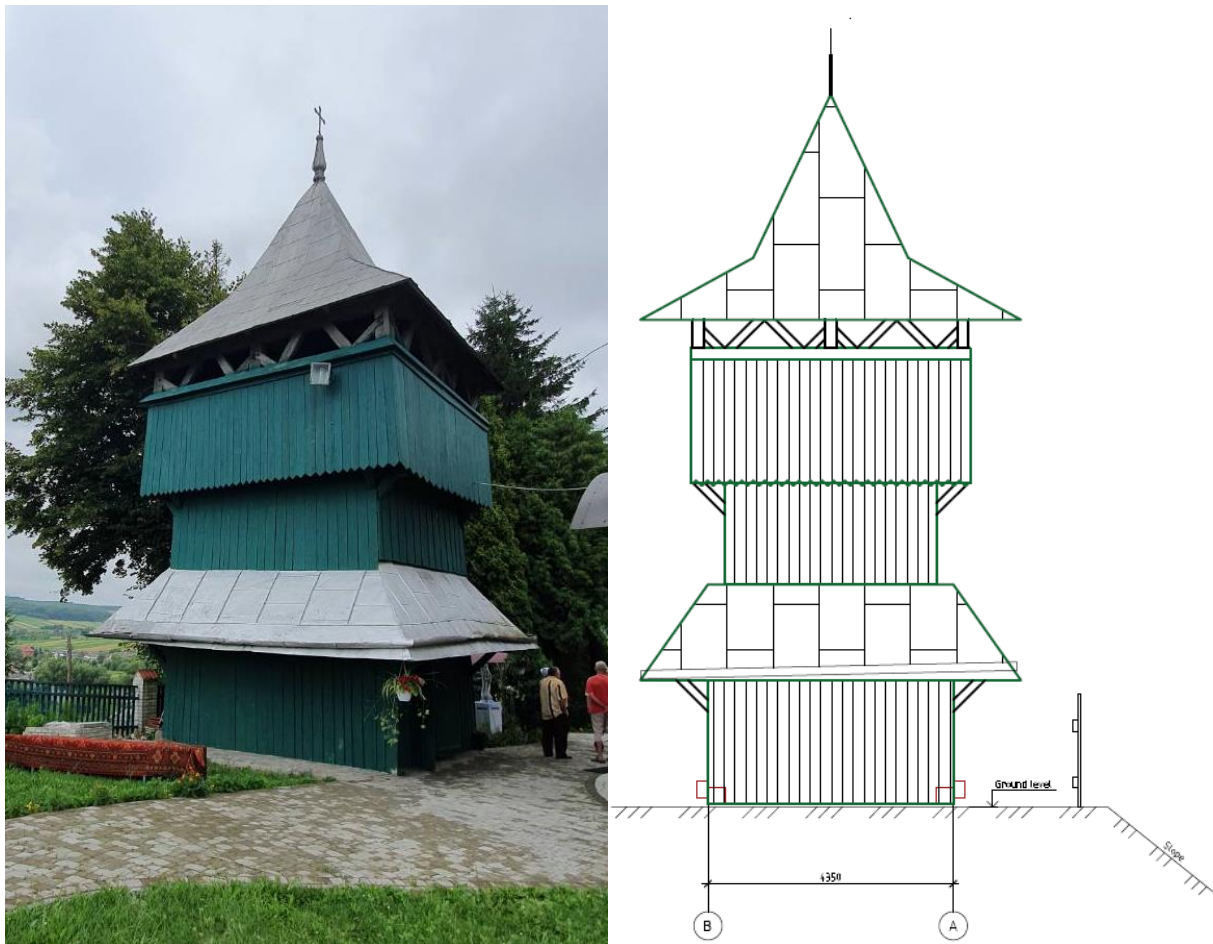
The existing building was built approximately in the 18th century (figure 1).

Figure 1. General view of the inspected building.

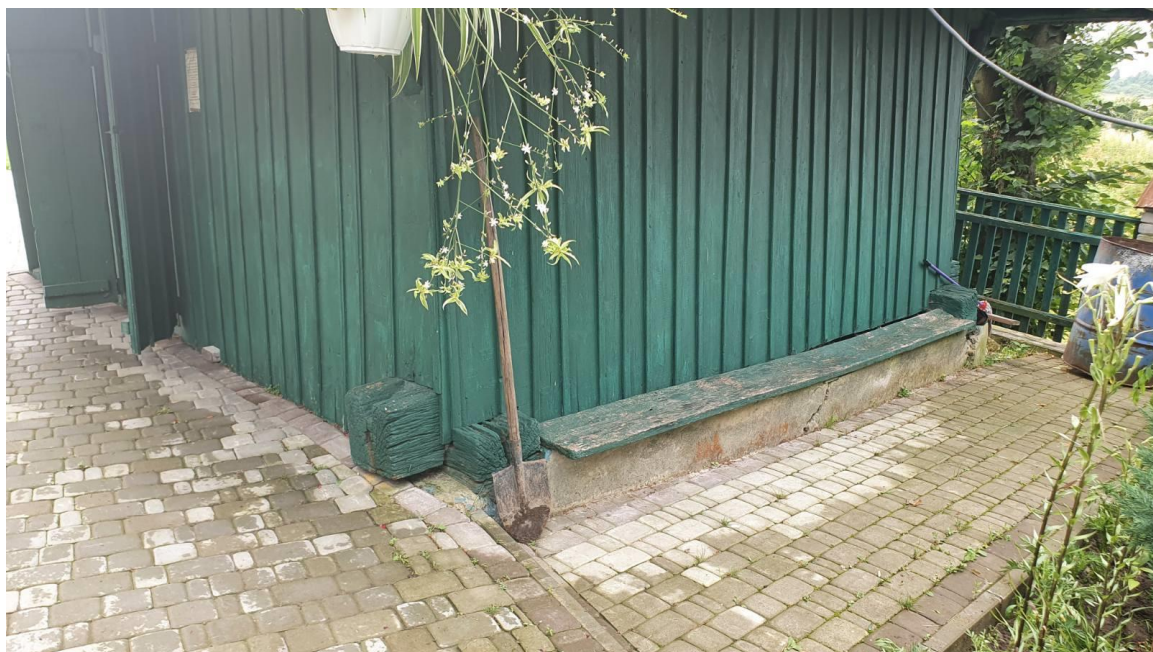
The bell tower is paved with cobblestones (figure 2)

Figure 2. View of support beds and beams

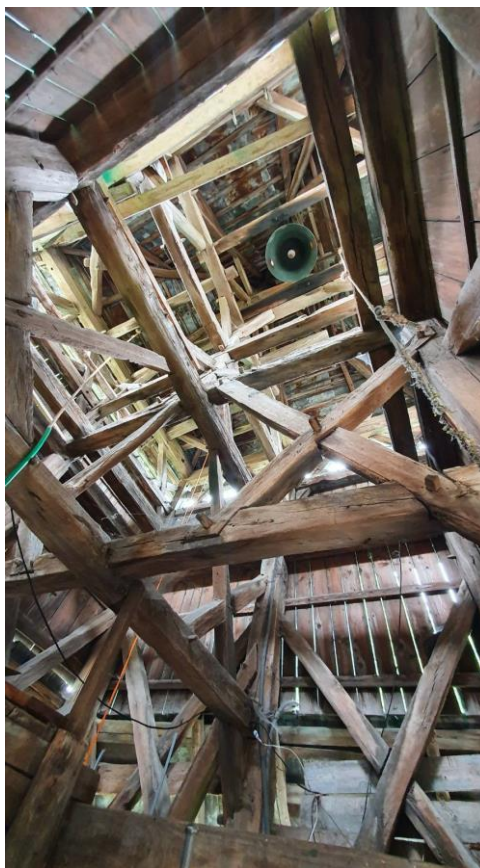
Structural scheme - wooden frame (figure 3).

The rigidity of the structure in both directions is provided by a wooden frame made of columns, joints and braces (figure 3).

Figure 3. General view of structures from the inside

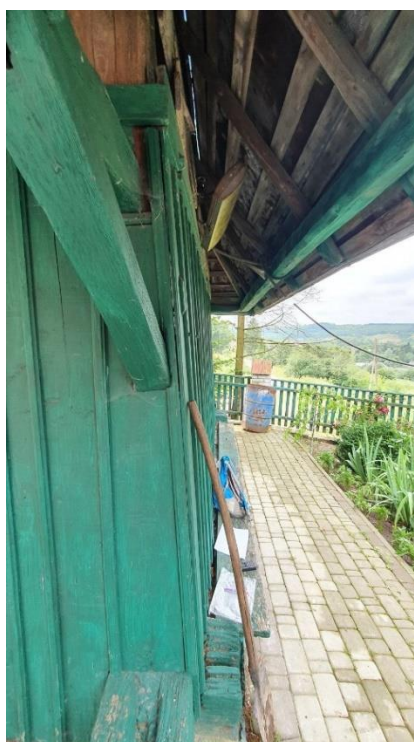
Subsidence of the foundations under the supporting wooden beds along axis A was detected, as a result of which the wall tilted along axis 1 (photo 4).

Figure 4. View of the inclined side wall

Design solutions have been developed to replace the foundations of the bell tower to preserve the structure (Figure 5, 6).

- 7 days after the installation of all the foundations, it is necessary to install the tower in a vertical position by wedging the supporting wooden planks along the length of the foundations with oak or steel wedges. If necessary, use jacks to raise the supporting wooden beams;

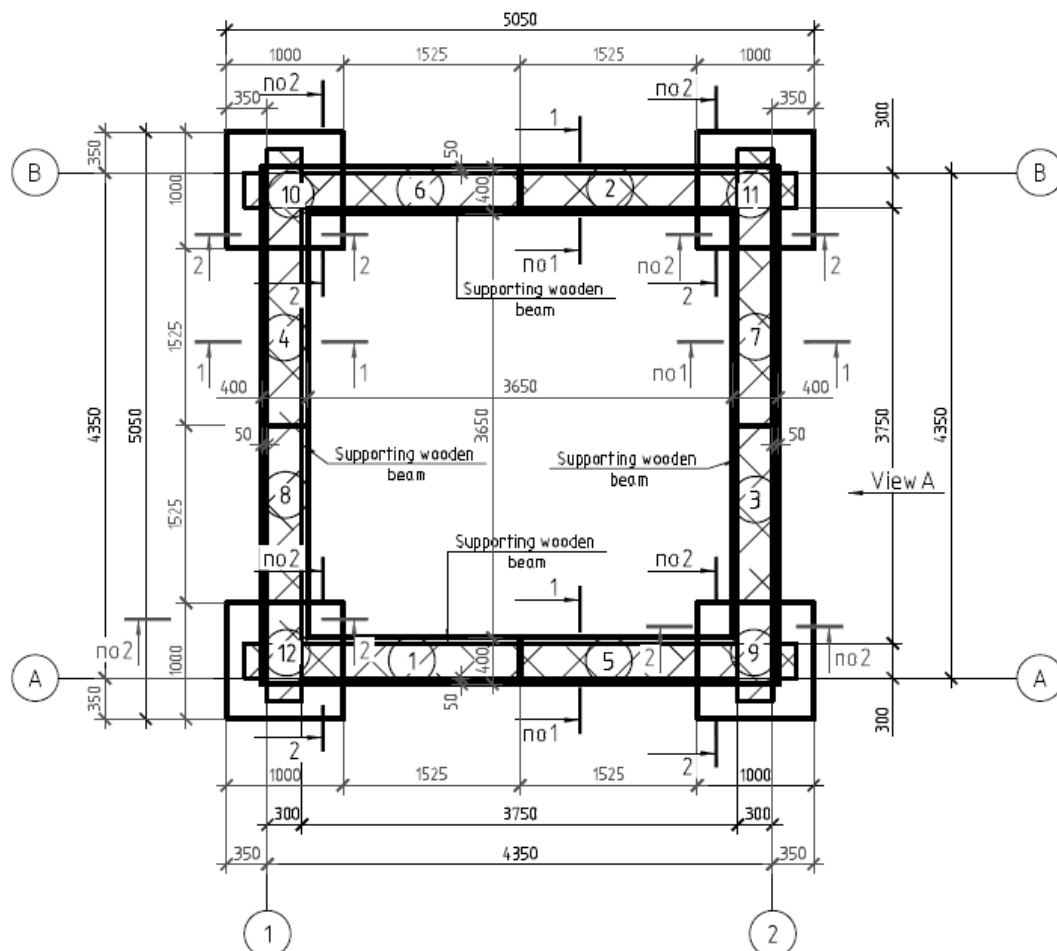
Figure 5. Scheme of strengthening the supporting wooden beams of the bell tower structure

- under a monolithic foundation, perform concrete preparation from concrete of class C8 / 10;

- the foundation device should be carried out in sections according to the scheme. The device of adjacent sections must be carried out no earlier than 7 days after completion of work on the adjacent section;

- when arranging foundation grips, lay 2 layers of roofing material under horizontal beds and beams with an overlap on adjacent sections of at least 200 mm;

- after wedging and bringing the tower to a vertical position, it is necessary to grout under the wooden beams and beams with a cement mortar of at least M200 along the entire perimeter at their contact with the foundations.

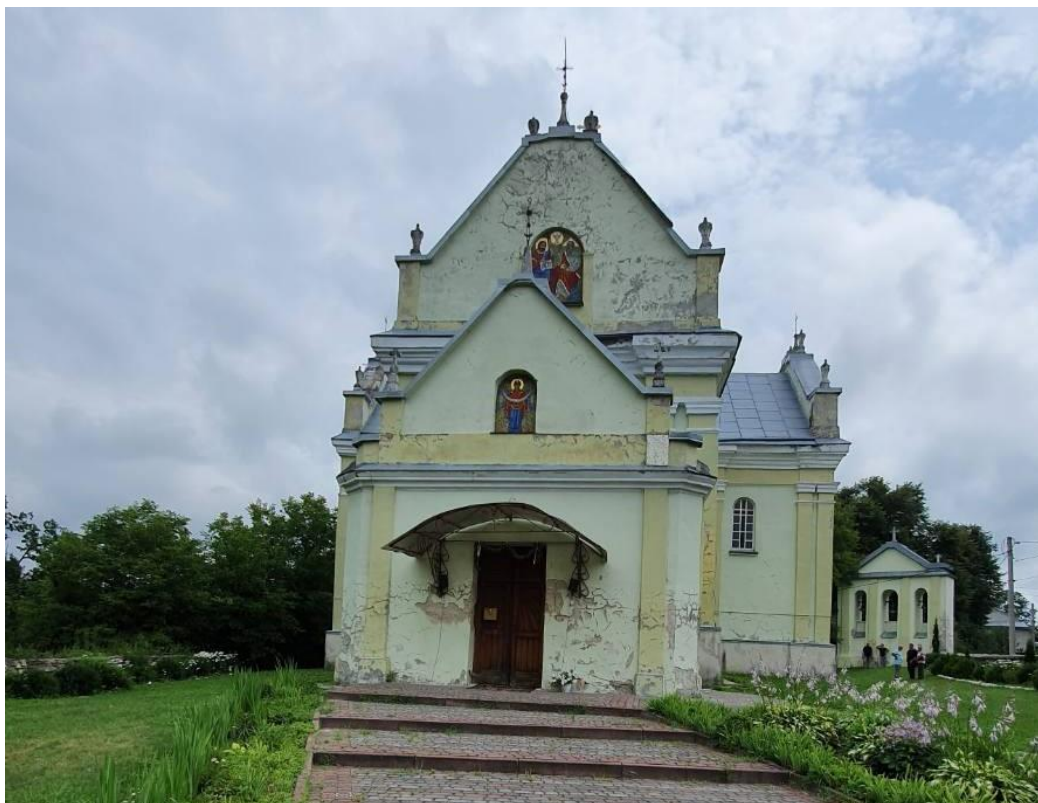
Surveyed public building, built in 1546-1561 (Figure 7).

Figure 7. Head facade.

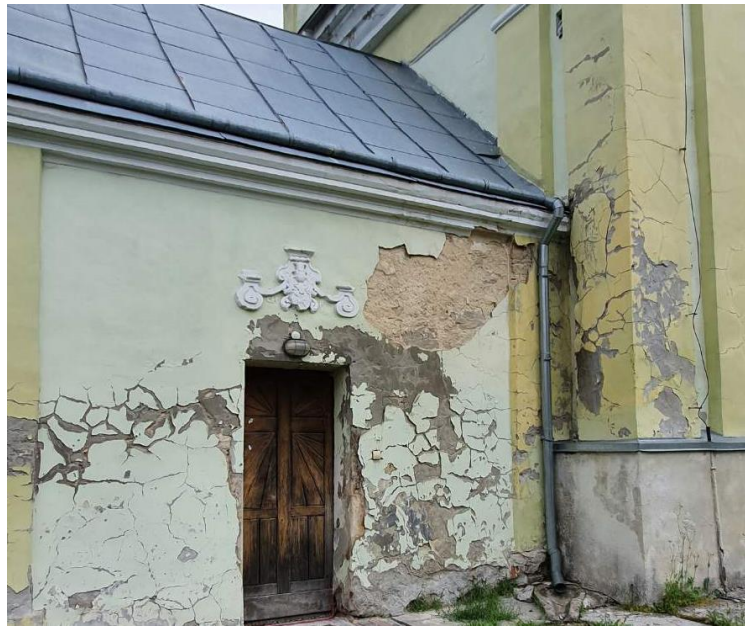
Figure 8. Damage to the facade and blind area.

- carry out repair work on the restoration of the exterior finish of the facade using modern facade plasters and paints;

- repair the blind area with organized drainage of water from it through the tray into the drainage channels to prevent rainwater from entering under the base of the foundations and on the walls of the basement;

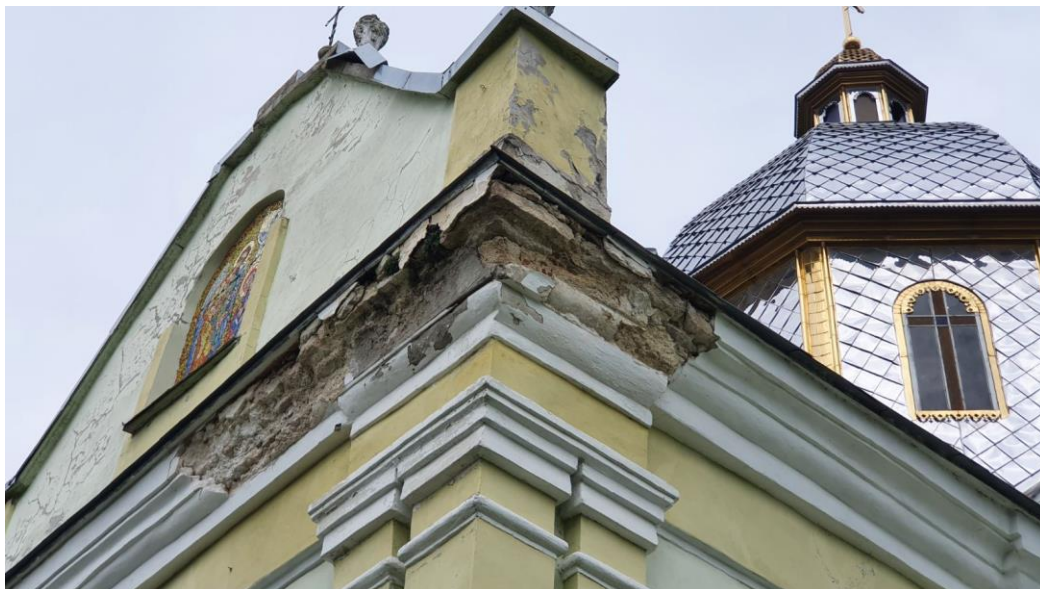
Figure 9. Damage to the cornices on the facade of the building, finishing of the facade and roof elements.

- perform local repairs of the roof with a possible change in the slopes of the horizontal roof gutters from the places of perpendicular joints of the outer walls;

- to repair the existing system of external drainage of rainwater (downpipes-chute);
