**1.1 Reconstruction of built-in boiler room**

This study examines one of these buildings - the administrative and household building (Fig. 1) of an industrial enterprise, located on the territory of the former house-building plant #2 in the village of Masonry of the Lviv region. The body is made of different volumes separated by deformation seams.

The purpose of the reconstruction is to improve the equipment of the built-in boiler room with the replacement of solid fuel boilers. The boiler house under investigation is built into the existing administrative and domestic building (Fig. 2).

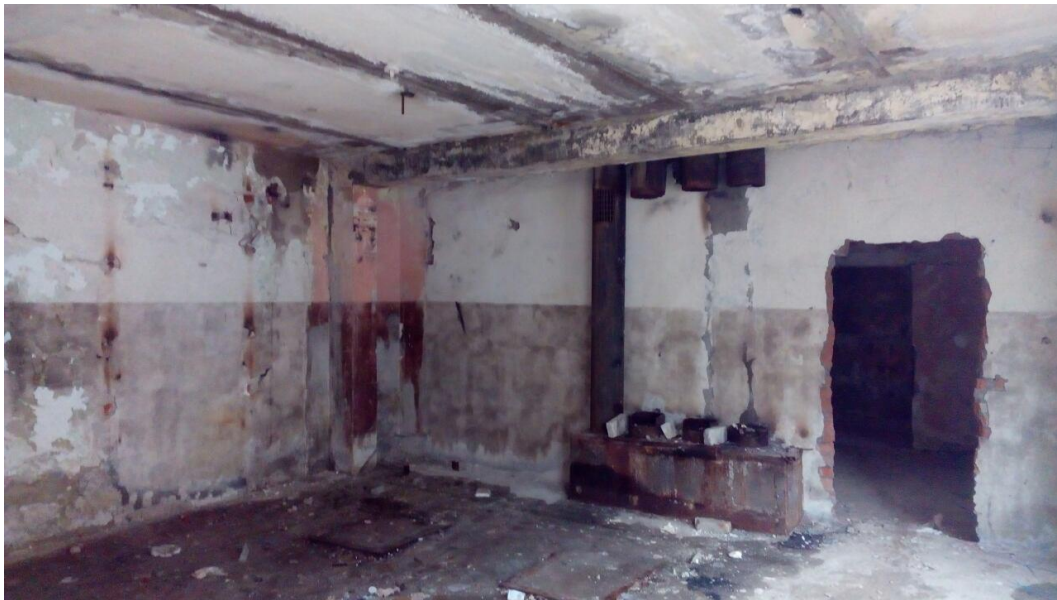
Figure 4. View of the room in axes "8-9/A-B"

Reinforced concrete crossbars, T-shaped cross-section, 400 mm wide, 450 mm high with undercuts for resting on column consoles (Fig. 4).

Cover and cover hollow reinforced concrete slabs (link, wall, row) 220 mm high, 1200 mm and 1500 mm wide. The slabs rest on the shelves of the brand crossbars (Fig. 4).

According to the analysis of the results of the survey, it was determined that the main supporting and enclosing structures: foundations, columns, crossbars, slabs and ceilings, wall panels are in the "2" category of technical condition - satisfactory. However, the structures of windows, doors, and floors are in the "3" category of technical condition - not suitable for normal operation and need repair or replacement.

During the reconstruction, above the boiler room in the "8-9/A-B" axes, a partial lifting of the covering by 700 mm is provided. At the request of the customer, two versions of the coating structures were developed in these axes (with maximum preservation of the existing structures and completely new structures).

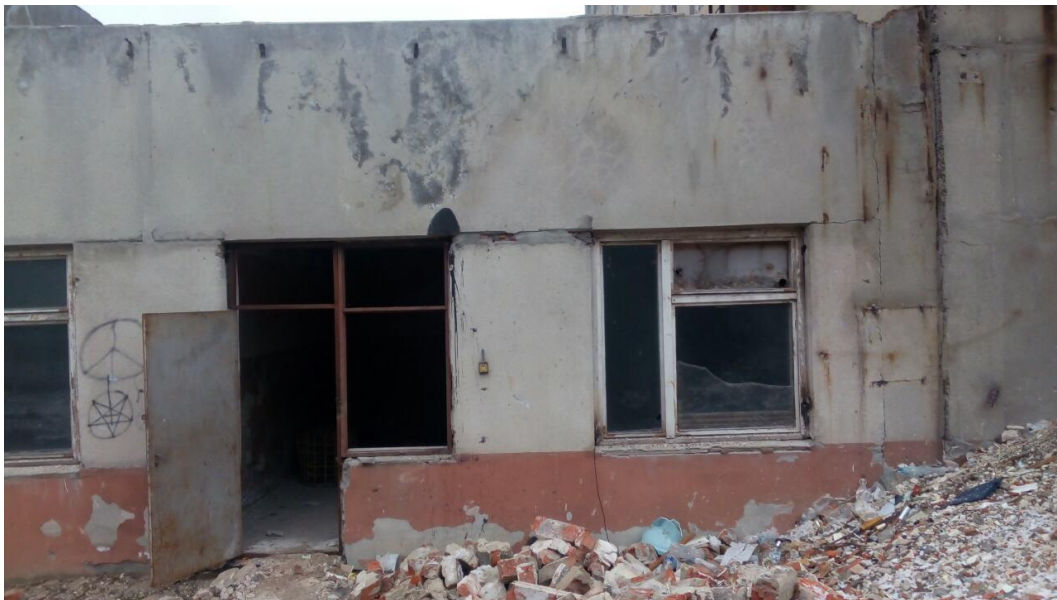
Figure 5. View of the facades of the existing building along axis "A" in axes "8-10"

The outer walls are made of hinged expanded clay concrete panels with a thickness of 300 mm (Fig. 5). The lower row of wall panels rests on foundation beams.

External walls made of expanded clay concrete panels are insulated with polystyrene foam plates 100 mm thick with openings framed with basalt wool 300 mm wide.
