### **2.1 Preservation and restoration of the wooden church, which is a spiritual, historical and cultural heritage**

We will consider the technical condition of the load-bearing structures of one of these churches using the example of the technical condition of the building of the wooden Church of Saint Michael the Archangel in the village of Stanislavchyk, Lviv region (Figures 1 and 2).

The purpose of the work: determination of the technical condition of the building of the wooden Church of Saint Michael the Archangel in the village of Stanislavchyk, Lviv region (hereinafter - the church).

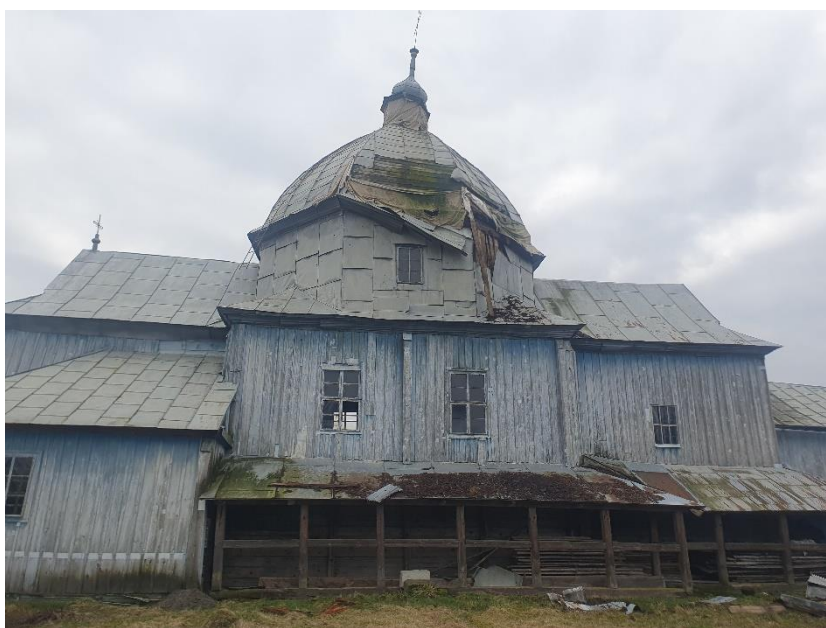
Figure 2. The facade of the church in axes 1-6.

Bell tower. In addition, we can say about the state of emergency of the bell tower, in which there is destruction of the board elements of the walls, structural elements of the second floor (loft), stairs, and the state of emergency of the dome (Figure 2).

3. The belfry structure under inspection is in an emergency (4) condition.
4. It is necessary to carry out work on streamlining the legal status of the church and its registration with the relevant state authorities and BTI.

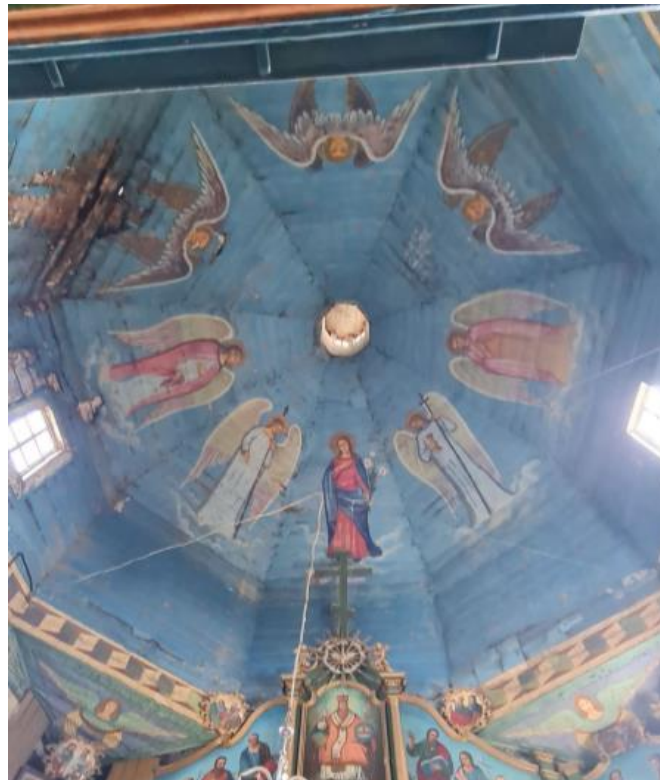
Figure 6. Photo of the dome from the inside

Dome. A survey of the dome from the middle of the church showed the following:

- in the vertical walls of the dome (the lower part) there are traces of a large lock and the destruction of the decorative layer, possibly due to the decay of the boards;

- on the four angles of support at the intersection of axes 3, 4 with axes A, E, especially above the Chores in the corner inclined elements, their emergency state due to constant moisture was recorded;

- you can see the places of through holes through which sunlight enters the Nava, rain and melt water, birds;

- the windows on the Signaturka and its walls are partially destroyed, which is the reason for the entry of birds into the space of the church, which leave a significant amount of waste products.

The main shortcomings of the dome listed above indicate its emergency condition.

- perform a detailed instrumental technical survey of the church building and bell tower;
- carry out a project to restore the foundations under the entire church building;
- execute a project to strengthen wooden longitudinal and transverse walls;
- carry out a project to restore the structures of the dome and tent roof with a complete replacement of the roof;
- execute the project of strengthening and restoration of structures and the roof of the Gallery;
- perform work on installation of water drainage systems from the church and from the church;
- perform repair or replacement of glazed window frames and doors;
- repair or replace the floor.
