## SECTION 1. ARCHITECTURE, CONSTRUCTION

### 1.1 Investigation of metal silos structures to determine the cause of their destruction

The silos to be inspected are located on the territory of the complex of the grain-receiving enterprise in the Khmelnytskyi region. Nine silos are located in a cascade and are connected to each other in a common technological process by galleries above the silos (Fig. 1, 2, 3). Each silo is 27,4 m in diameter, the wall height is 18,7 m, the total height with the dome cover is 27 m.

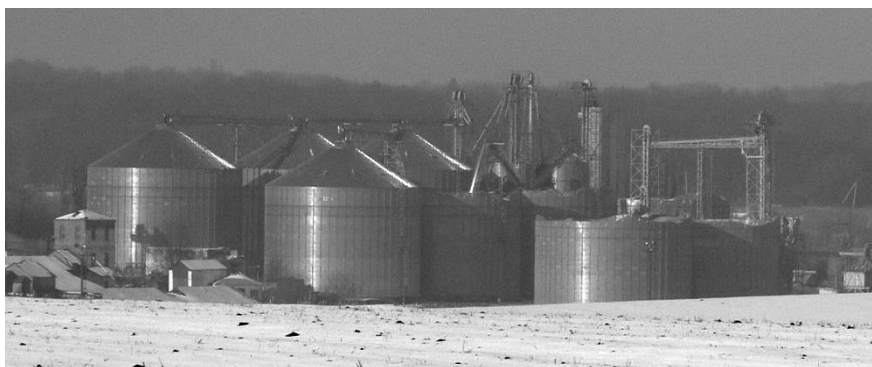
At the time of the survey, five of the nine silos were destroyed (Figs. 2, 3). Their numbers in order of destruction: #9, #7, #5, #3, #4.

Figure 2. View of the silos from the southeast, after the destruction of the silos

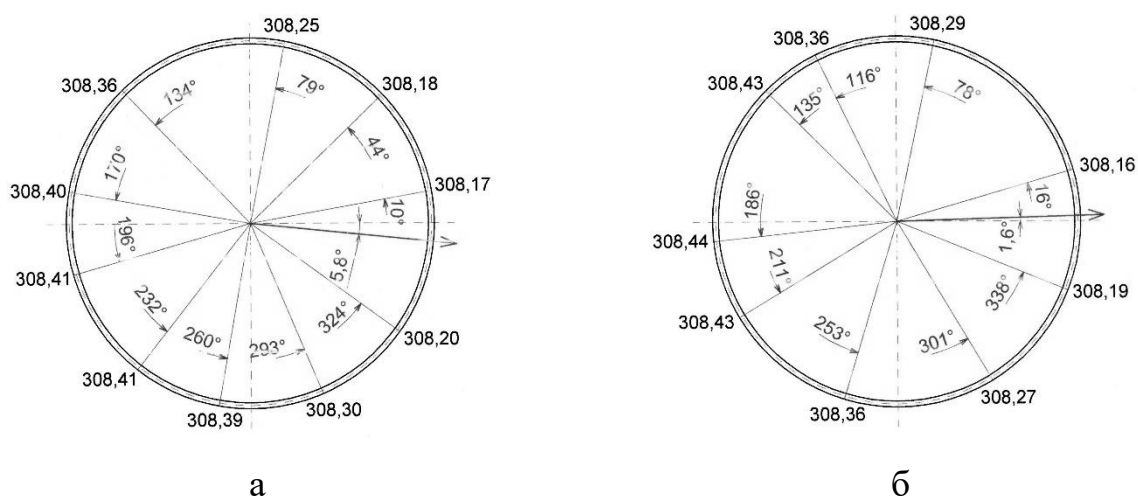
The angles of attachment of the beams from the center of the foundation to the marks along their perimeters  $\beta$  are determined. For example, the markings on the perimeters of the foundations for silo #1 and silo #2 are shown in Fig. 4.

Figure 4. The angle of direction of the maximum inclination of the bank and foundations of the silos: a – #1; b – #2

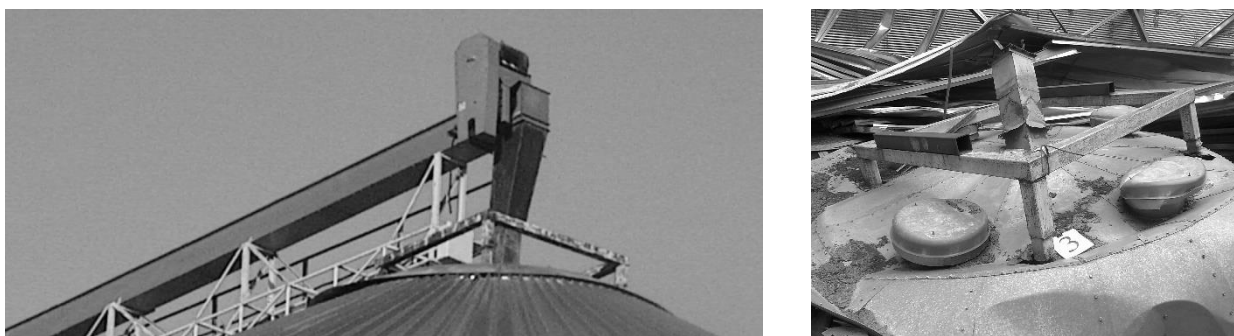
During the survey, the rigid attachment of the spatial lattice trusses above the silo conveyor galleries to the central ring of the conical coverings (Fig. 5) was recorded through a "chair", which is a faulty technical solution.

Figure 5. Rigid fastening of the lattice trusses of the conveyor galleries above the silos through the "chair" to the central ring of the conical cover

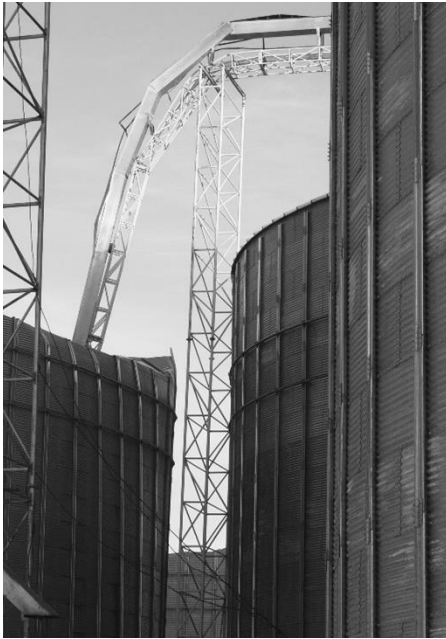
Some structures of intermediate supports are overloaded or have significant defects, damage, unreliable execution, which indicates an unconditional decrease in their bearing capacity and the need for repair. Part of the load-bearing elements of the intermediate supports above the silo galleries are in the 3rd category of technical condition (Fig. 6). This is due to the fact that the lattice structures of the intermediate vertical supports of the galleries have structural and strength defects in the nodes of fastening of braces and braces to the posts, as well as the absence of braces and braces since installation.

Figure 6. Lattice vertical rack between silos #4 and #6 and continuous lattice truss of the conveyor gallery

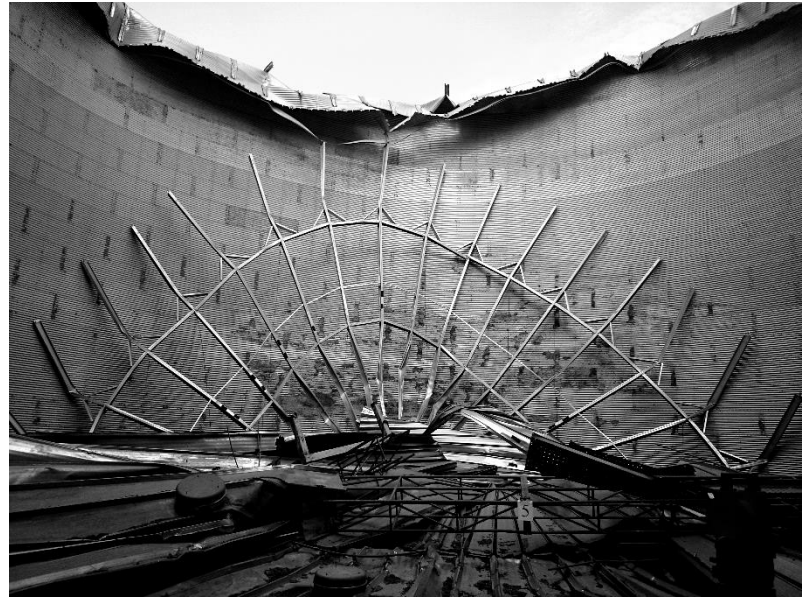
which helped to assess the impact of defects and damage on the sequence of destruction of silo coatings (Fig. 7) and the silos themselves.

Figure 7. Hanging of the destroyed elements of the load-bearing structures of the conical coverings of silo #5 on the contour of its wall
