## SECTION 2. ARCHITECTURE, CONSTRUCTION

### 2.1 Application of vertical ribs in walls for strengthening buildings and structures

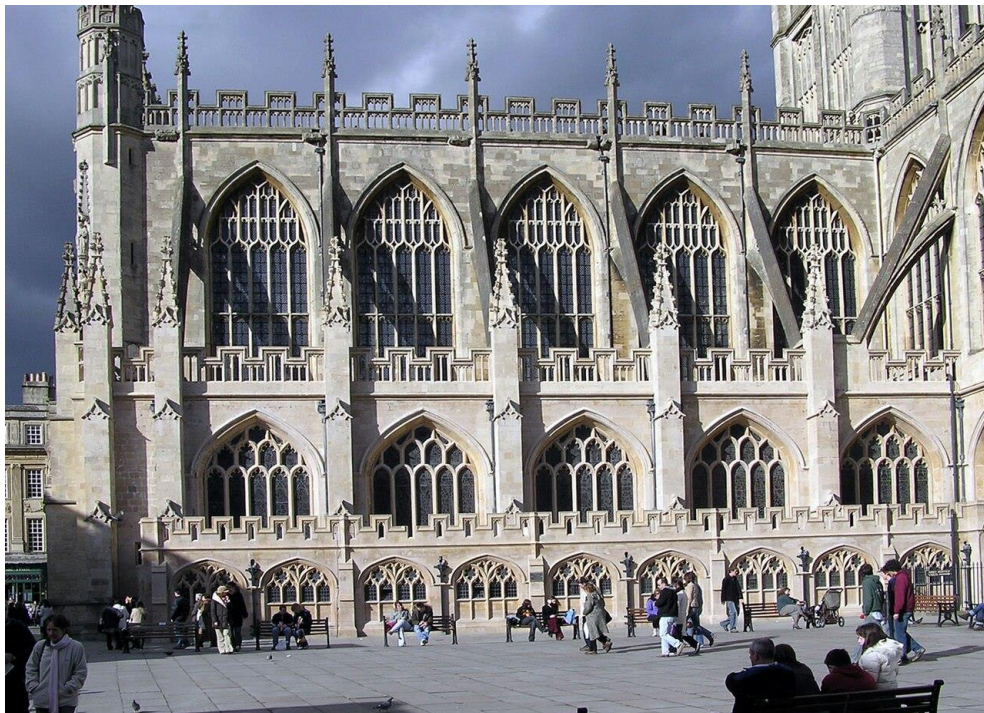
Figure 1. Application of buttresses in the building the Abbey Church of Saint Peter and Saint Paul (16th century)

Everyone knows the use of vertical, outwardly protruding parts of walls during the construction of buildings or structures, which are called buttresses [80]. Buttresses began to be used by the ancient Romans, but they became widespread in Gothic architecture (Fig. 1). During the Renaissance, buttresses almost completely ceased to be used in architectural and construction practice.

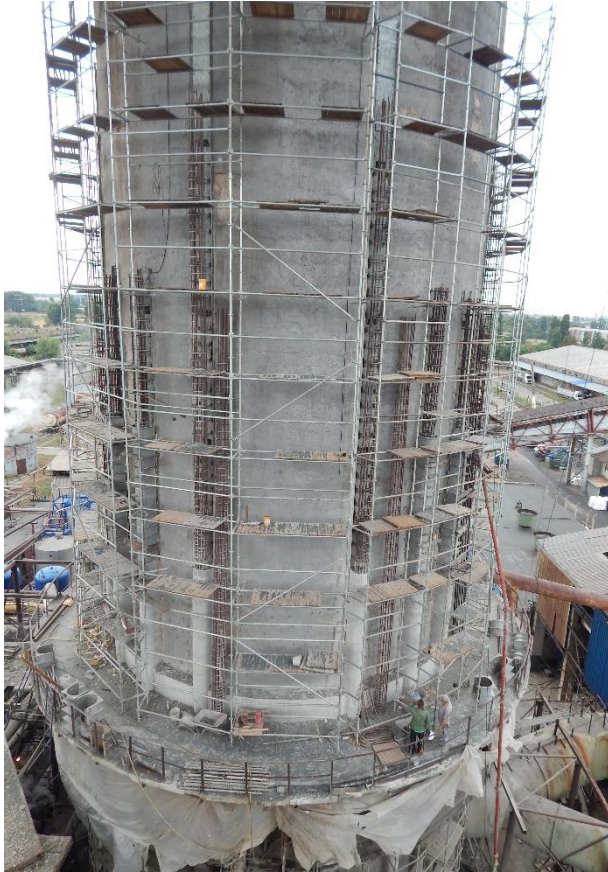
Figure 7. In the process of performing amplification

The repair of the ammonium nitrate granulation tower was carried out in 2020 (Fig. 7). In addition to strengthening the tower trunk, chemical protection of structures was carried out.

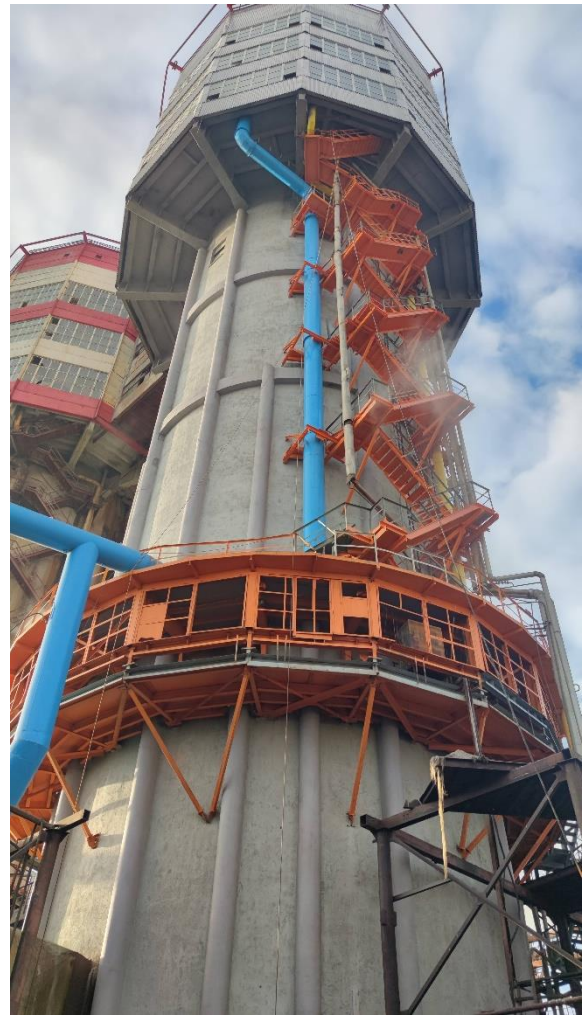
Figure 8. General appearance of the tower after strengthening and repair

The four-year operation period of the tower after strengthening and repair (Fig. 8) showed the correctness of the decision.

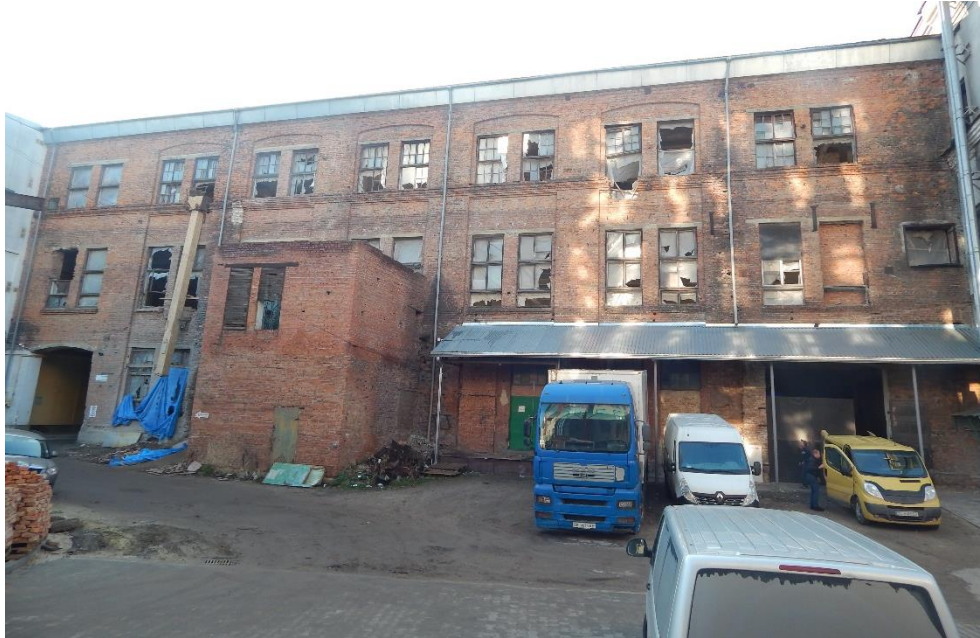
Figure 9. General appearance of the facade of the building during the survey

The second object was an industrial building in Lviv (Fig. 9) [84], which provided for the change of functional purpose to a public purpose with the addition of floors.

The existing three-story building is a combined structural system, with brick walls on the outside and reinforced concrete columns on the inside, is an insert building between other industrial and public buildings. The length of the building in axes is 45,415 m, the width is 20,34 m. The height of the 1st floor is 4,7 m, the 2nd – 5,7 m, the 3rd – 6,0 m. Under the part of the building there is a basement with a height of 4,2 m. Flooring – monolithic ribbed reinforced concrete slabs.

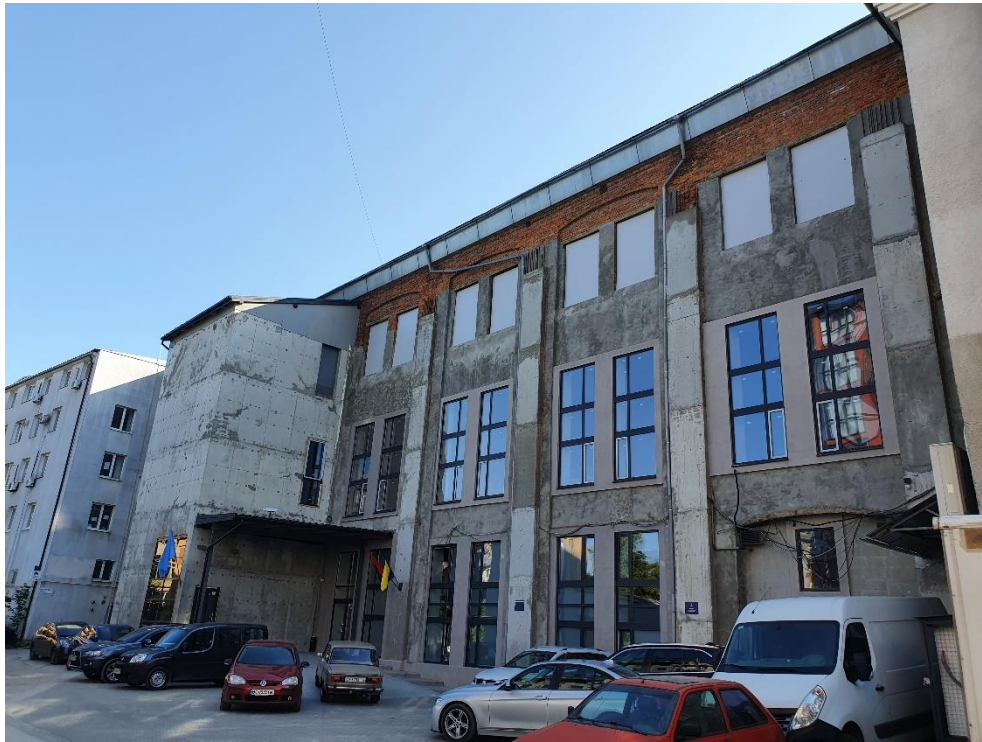
Figure 12. General appearance of the facade after reinforcement (at the stage without adding floors)

Reconstruction of the building began in 2021. In addition to the strengthening of the walls, work was carried out to strengthen the foundations [84] and columns. Currently, all works have been completed except for the addition of floors (Fig. 12).
