## SECTION 1. ARCHITECTURE AND URBAN PLANNING

### **1.1 Changes in the planning and form-making structure of a university academic building**

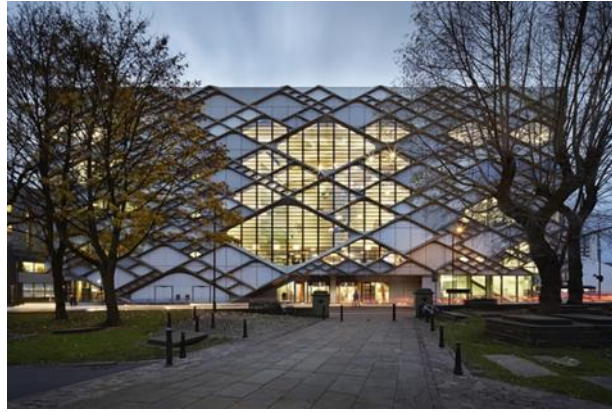
**Fig. 2.** Main façade of The Diamond [<https://www.ngbailey.com/case-study/45/the-diamond,-university-of-sheffield>]

One of the most relevant examples of contemporary university reconstruction is The Diamond building at the University of Sheffield (United Kingdom). (Fig. 2). This 6-storey building for the Faculty of Engineering opened in 2015 and replaced an outdated facility, enclosing a new space with laboratories, lecture halls and open learning areas. Its façade is executed as a unique aluminum modular “shell” with a rhombic pattern over a concrete frame and glazing.

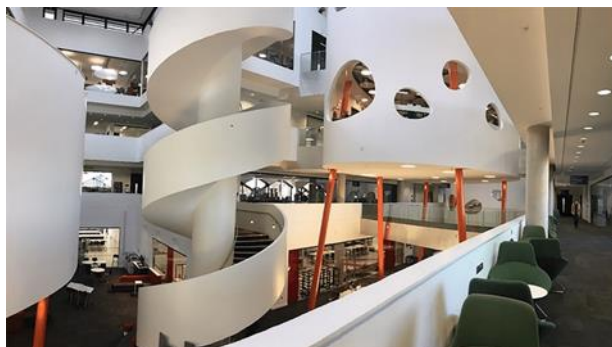
**Fig. 3.** Central atrium [ <https://www.ngbailey.com/case-study/45/the-diamond,-university-of-sheffield>]

The central atrium of the academic building (Fig. 3) serves as a distribution space: it unites lecture theatres, workshops, open-space areas, a café and places for independent study. Such a planning scheme ensures a high level of natural lighting, spatial flexibility and comfortable social interaction.

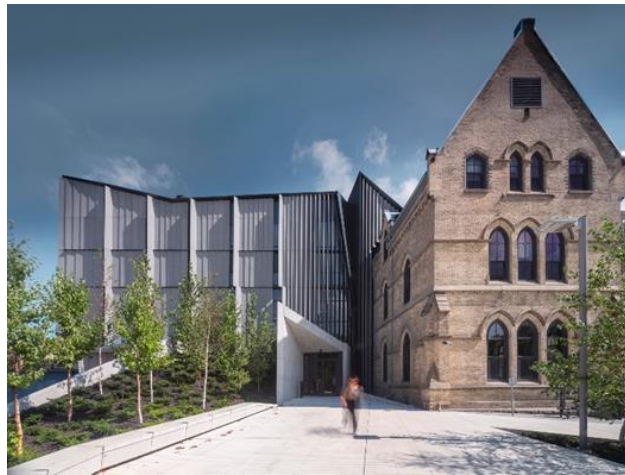
**Fig. 4.** General view of the historic building with modern extension

Daniels Building on the campus of the University of Toronto (Canada). (Fig. 4). The 2017 project combined the restoration of a historic 19th-century neo-Gothic building with a modern extension. The new part is created from steel, concrete and glass — it contrasts with the historic part, creating a modern educational and creative space. Inside the building, a spacious “interior main street” has been formed, which unites studios, workshops, exhibition halls, a library and gathering areas, accumulating educational, research and social functions.

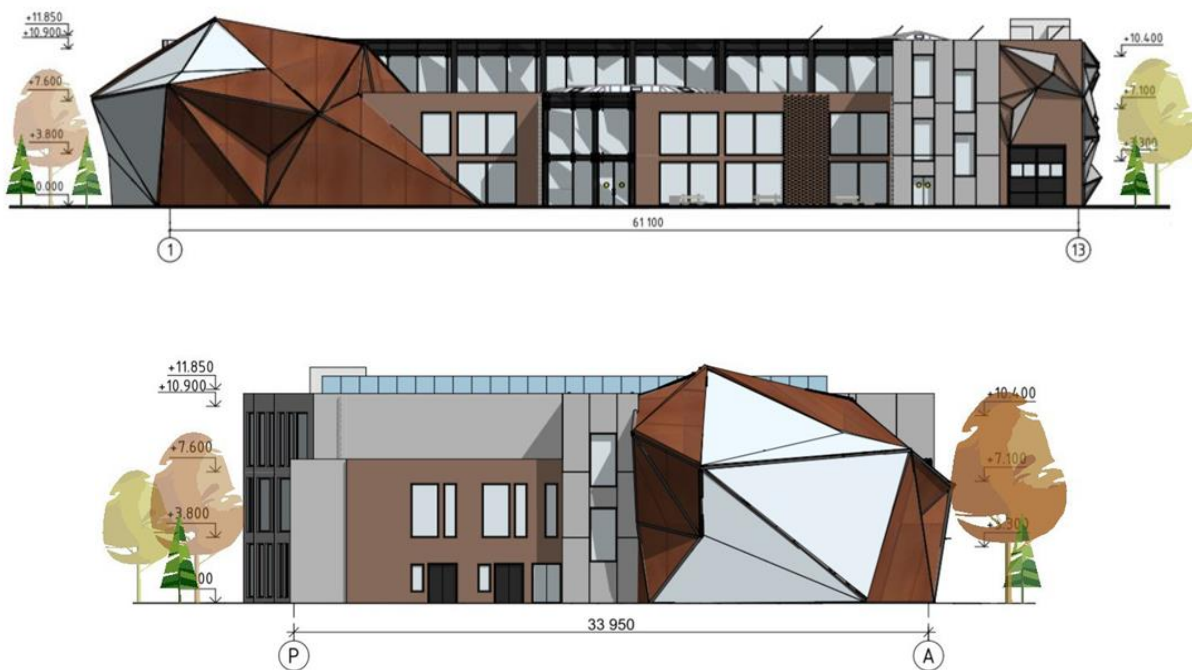
**Fig. 6.** Facades of building [Author's development]

It was decided not simply to restore the existing structure of the building, but to rethink it in a contemporary architectural context. The basis of the design solution is the aspiration to create a volumetric structure that provides a transition between the existing reinforced concrete frame and the new part of the building. The new volume is made of metal structures, which makes it possible to create complex geometric forms and ensures openness and flexibility of the internal space. Broken planes and a fragmented silhouette reflect the dynamics and directions of spatial transformation, emphasizing a distinctive architectural accent.

In the place of the destroyed part of the building, contrasting materials were installed — metal panels and glass, which differ from the main part of the building, making it possible to combine functionality and symbolic meaning. Such a solution forms a space that is a kind of marker of change and renewal, and also emphasizes the significance of the building within the structure of the campus. (Fig. 6).

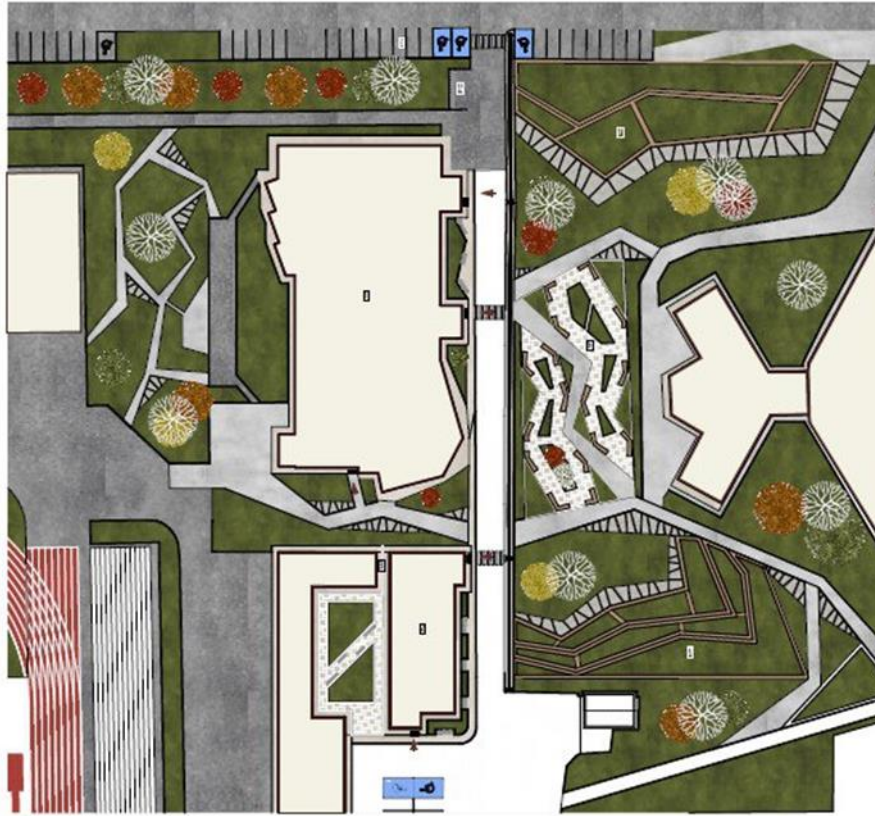
**Fig. 8.** Master plan [Author's development]

The master plan of the reconstruction acts as a basic structural model that transforms a previously inefficiently organized site into an orderly, functionally coordinated, and modern educational space. It forms a new zoning system in which the territory is divided into a group of clearly defined functional sectors that increase the rationality of land use and ensure safe movement of users.

The recreational green zone, which occupies the largest part of the site, is formed as a complex landscape space with terrace benches with greenery at different levels, pathways, and expressive terrain geometry. It functions as an informal communication environment, a place for rest and social interaction.

The transport zone (entrances, parking, and technical access) is assigned to the periphery of the site. This localization minimizes the intersection of pedestrian routes with transport routes, reduces the risk of conflict situations, and ensures safe movement of students within the building area. Pedestrian connections with the possibility of fire truck access in case of emergencies are provided.

The geometry of the landscape repeats the stylized broken lines of the architectural facades, creating visual integrity between the outdoor environment and the reconstructed building. Particular attention is paid to lighting and navigation, ensuring convenient and safe use of the area in the evening. The combination of natural materials with modern surface finishes creates a diverse tactile and visual structure.

Inclusiveness is a fundamental principle of the master plan. All main routes have minimal height differences or are equipped with ramps in accordance with state

standards. Tactile elements and visual markers are placed in key movement areas, and site furnishings are arranged so as not to create obstacles. A high level of landscaping emphasizes the priority of forming an environmentally sustainable and comfortable public space in accordance with modern educational environment standards. (Fig. 8).
