## SECTION 6. CONSTRUCTION AND CIVIL ENGINEERING

### 6.1 Modernization of an existing industrial building

The article describes an example of changing the functional purpose of a production building through reconstruction.

It was necessary to develop structural solutions to change the existing high-rise single-story manufacturing space into a three-story office building with a roof terrace.

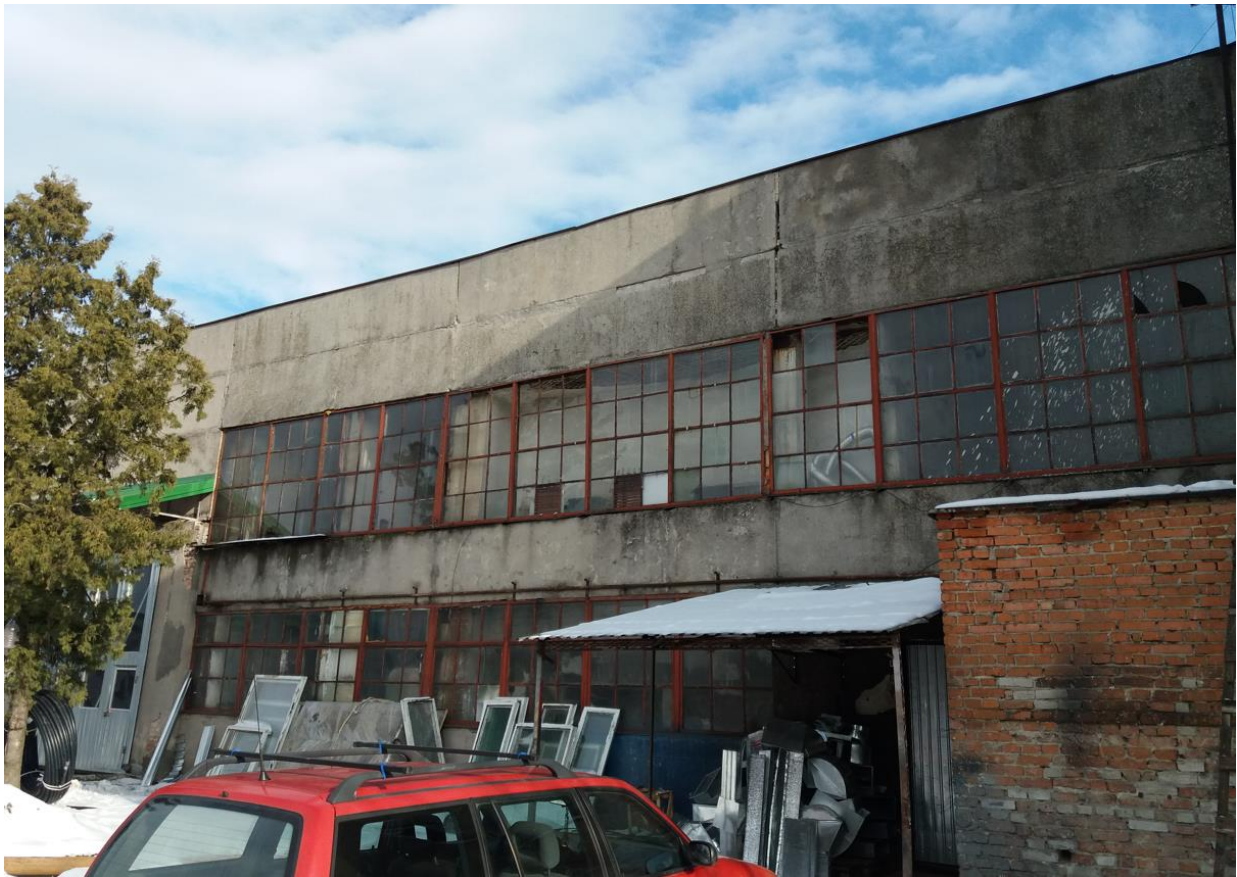
**Figure 3.** Existing building facade before reconstruction [made by the authors]

Along axis 4, the building is adjacent to a frame administrative building, along axes 1 and B, there is a production part, which is structurally similar to the part of the building under investigation. The plan of the first floor of the part of the building being reconstructed is shown in Figure 1, and a section of the building is shown in Figure 2, and a photo of the existing facade of the building is shown in Figure 3 (all the drawings mentioned are the author's own designs and photos).

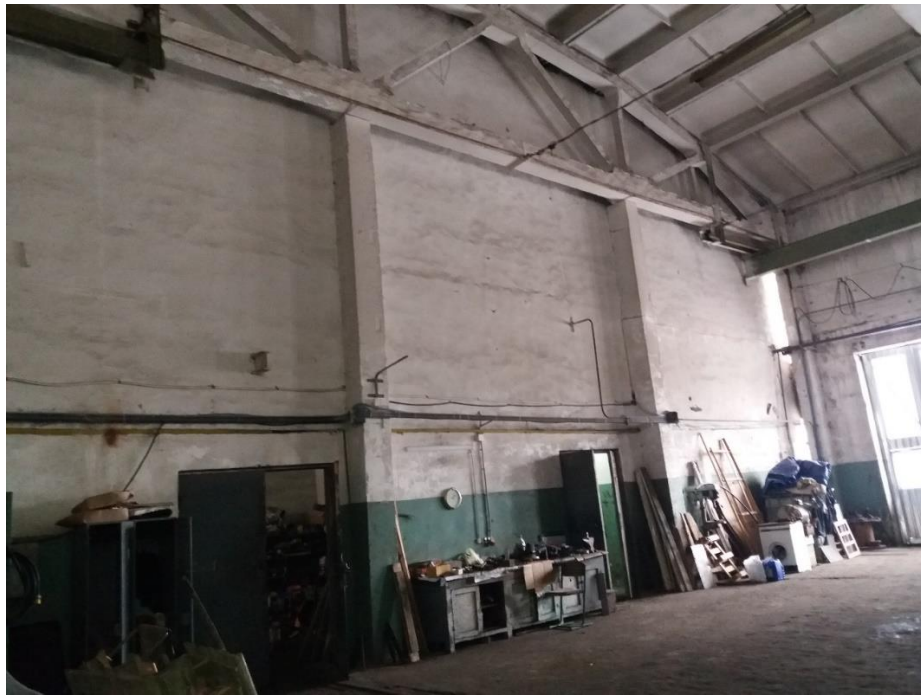
A photo of the existing interior of the building is shown in Figure 4 (this is the author's photo of the authors of the article).

**Figure 4.** Photo of the existing interior of the building [made by the authors]

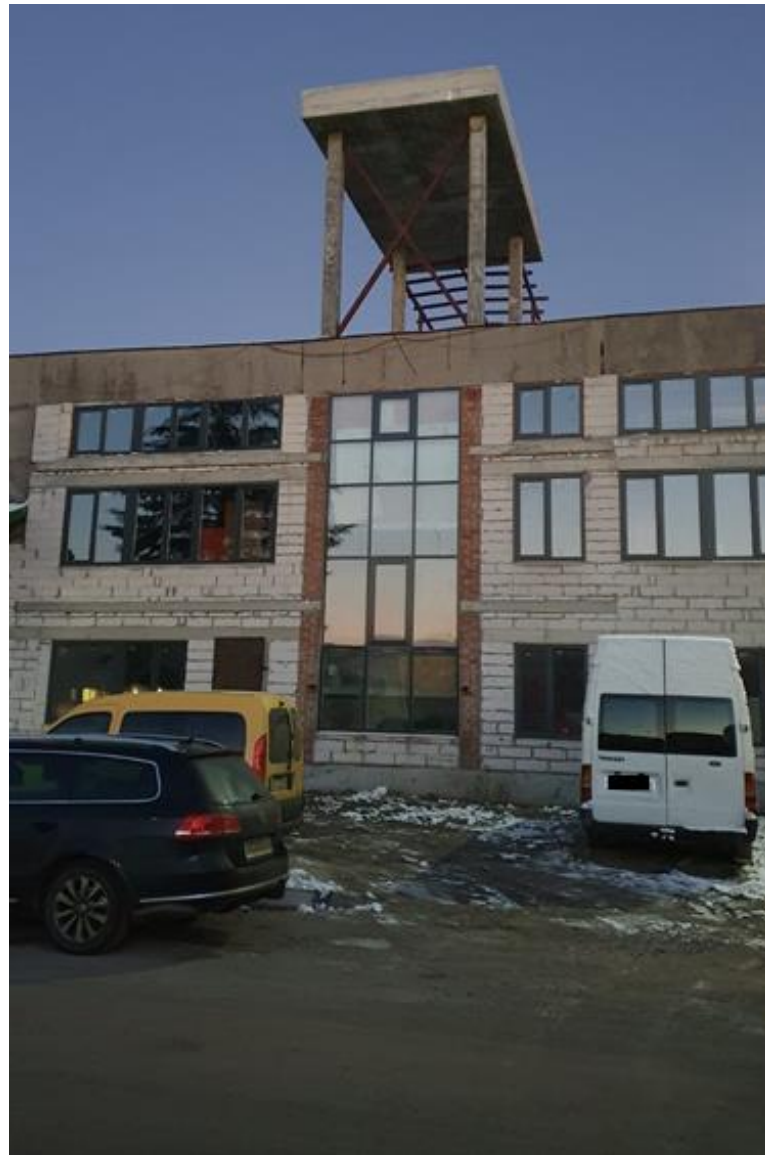
Figure 8 (this is the author's photo of the authors of the article) shows the modified facade of the building (at the time of taking the photo, the facade decoration had not yet been completed).

**Figure 8.** Changed building façade [made by the authors]

Also, Figure 8 shows that during the works, access to the roof of the building was organized, where a large terrace with the possibility of arranging a recreation area was designed. A photo of the roof at the location of the terrace is shown in Figure 9 (this is the author's photo of the authors of the article).

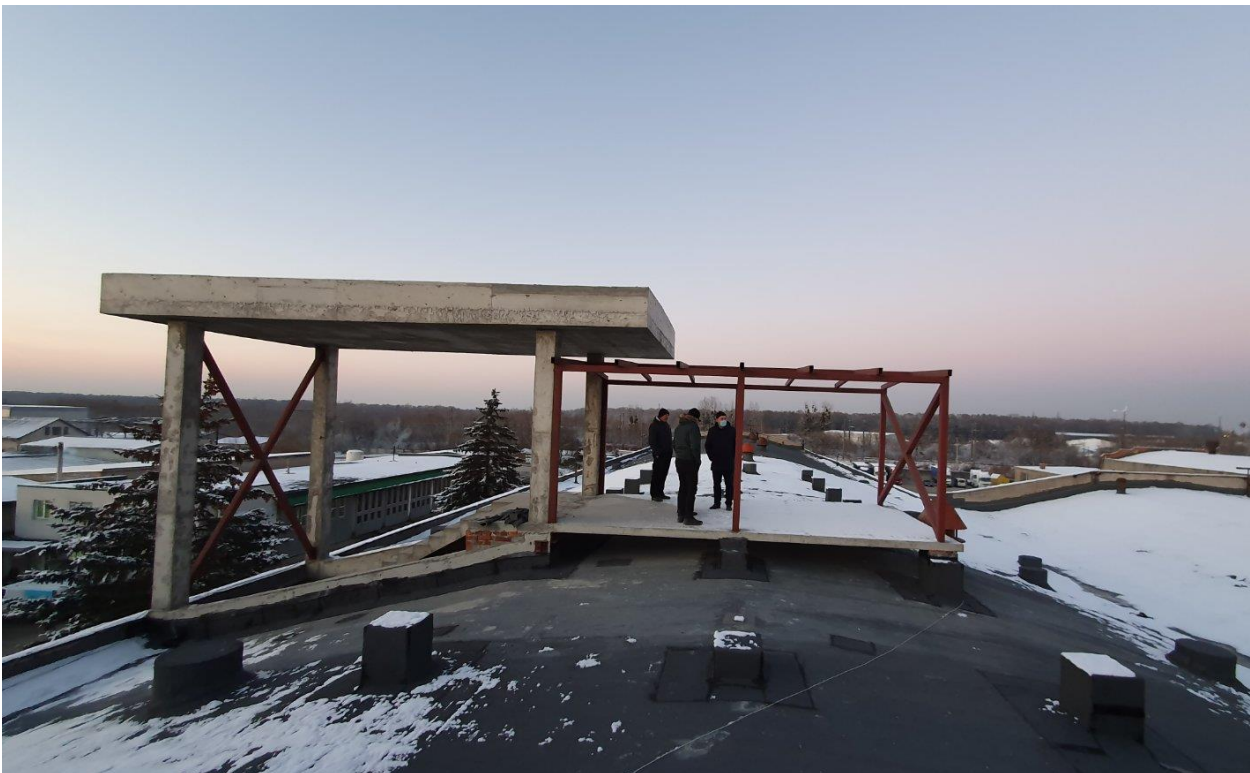
**Figure 9.** Roof at the terrace location [made by the authors]
