## 1.4 Analysis of the interaction of groups of buildings within the boundaries of dense building

With the participation of the author, work was carried out on the technical inspection of buildings on Olena Stepanivna street in Lviv. The work was carried out in order to determine its actual technical condition and, if necessary, to provide recommendations on the elimination of identified deficiencies.

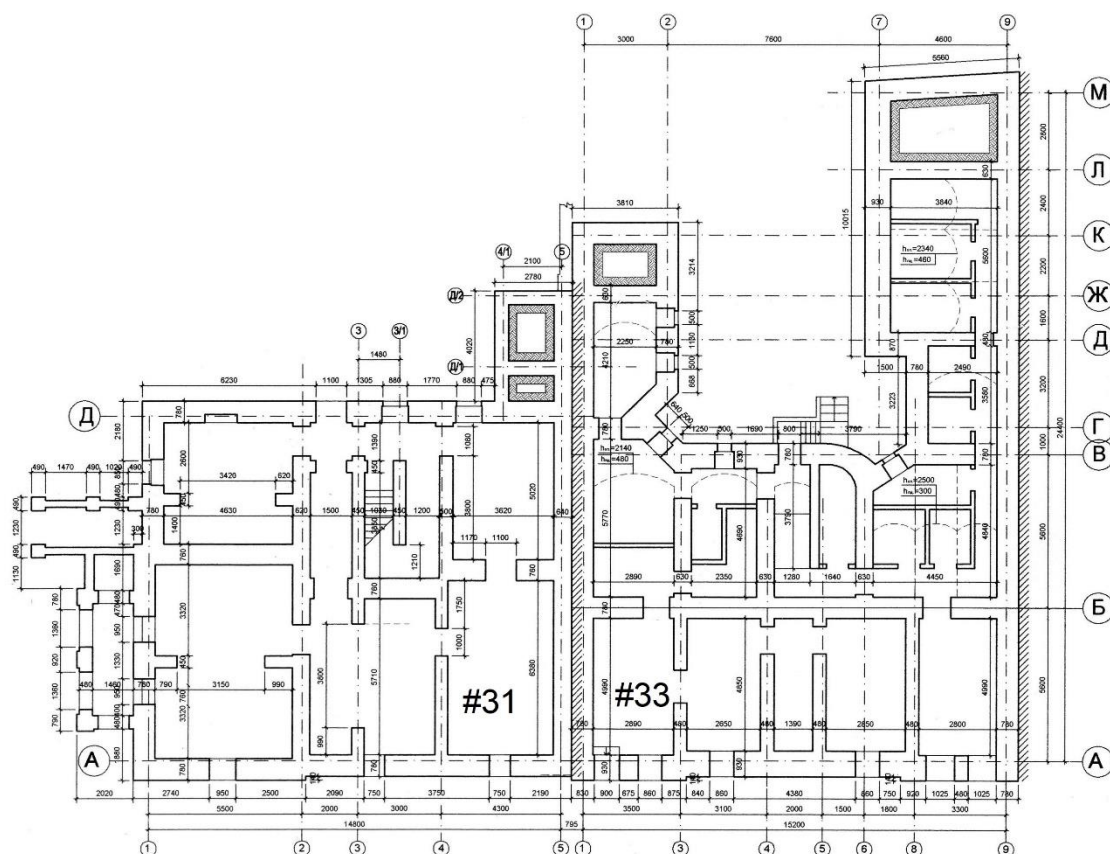
Figure 2. Basement floor plans of buildings #31 and #33

The main attention was paid to buildings #31 (an architectural monument of local importance) and #33 (Fig. 2). Both buildings are located in the area of the long-standing low-rise residential development of this street. The study of archival materials and the different sizes and colors of the bricks of the walls of the buildings indicate that house #31 was built before house #33.

Overloading of foundations under the foundation of the load-bearing wall along axis "5" of building #31 and its increased subsidence caused by additional loading of the base of the foundation of building #33, which is located along this same axis "5" and lies 0,5 m above the base of the foundation along axis "5" building #31 (Fig. 3, 4). The soles of the foundations of building #33 along axis "1" are located in the backfill of the foundation along axis "5" of building #31, which was built 3 years earlier.

The increase in the spatial deformation of the frame of building #31 is mainly caused by the uncontrolled, uneven settlement of wet foundations under its foundations. This especially applies to the wall along the "5" axis. This was an unreasonable decision of the designers, from the point of view of the mutual influence of the extension on the adjacent existing building. At the same time, the sole of the foundation of building #33 is 500 mm higher than the sole of the foundation of building #31 and lies on the backfill of its foundation along the "5" axis.

It is necessary to constructively ensure the adhesion of the mortar to the brick by introducing vertical reinforcement to combine the foundation slab walls with the new monolithic slabs of the basement, 1st and 2nd floors in the vertical struts of the walls.

Increasing the strength and spatial rigidity of buildings should be achieved by strengthening structures in accordance with the results of its calculations in interaction with the foundation.

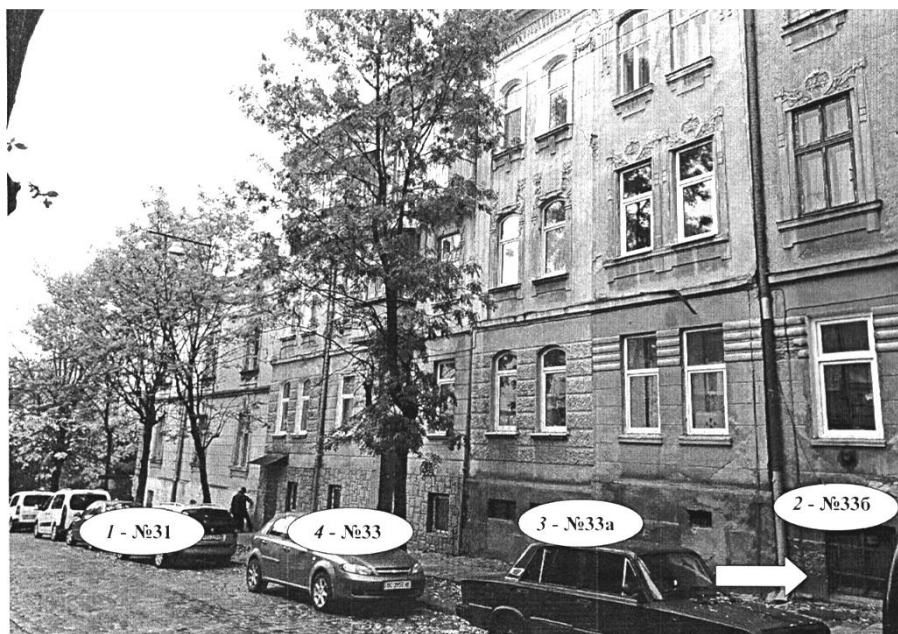
Figure 8. Photos of buildings: 1 - #31, 2 - #33b, 3 - #33a; 4 - #33, according to the sequence of their construction in the old compacted building

According to the analysis of the actual spatial deformations of the group of buildings within the block of the old building on the Olena Stepanivna street, the order of their construction is indicated in figure 8, 9, 10.
