**1.1 Reconstruction of built-in boiler room**

This study examines one of these buildings - the administrative and household building (Fig. 1) of an industrial enterprise, located on the territory of the former house-building plant #2 in the village of Masonry of the Lviv region. The body is made of different volumes separated by deformation seams.

The purpose of the reconstruction is to improve the equipment of the built-in boiler room with the replacement of solid fuel boilers. The boiler house under investigation is built into the existing administrative and domestic building (Fig. 2).

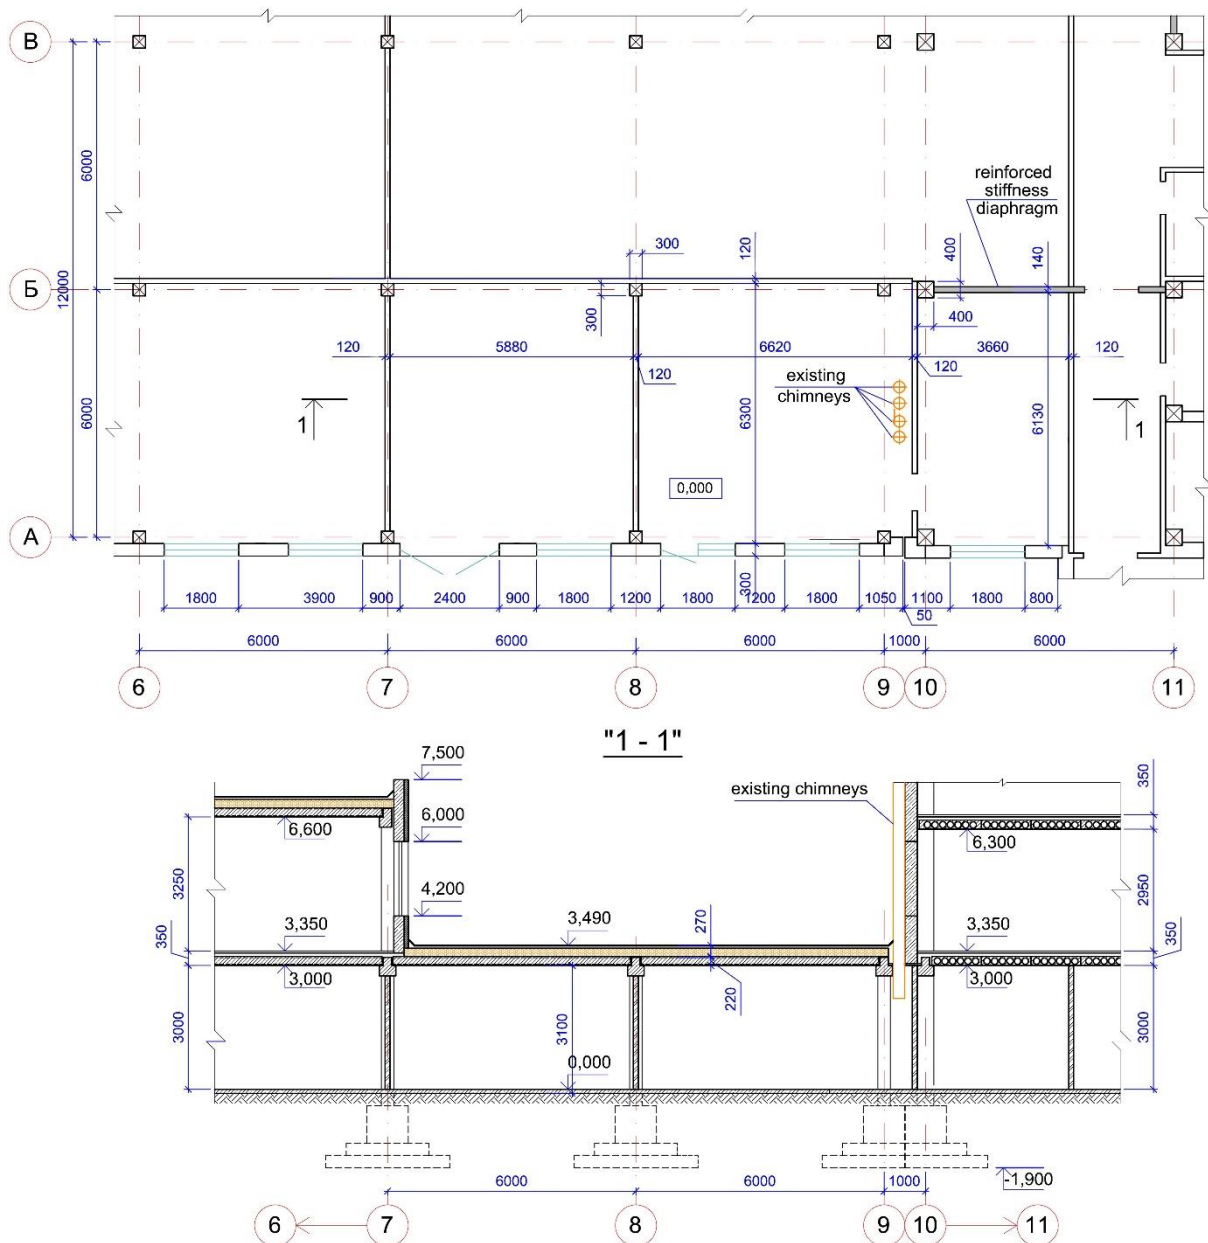
Figure 3. Plan and section of the existing building premises within the boiler house

According to the analysis of the results of the survey, it was determined that the main supporting and enclosing structures: foundations, columns, crossbars, slabs and ceilings, wall panels are in the "2" category of technical condition - satisfactory. However, the structures of windows, doors, and floors are in the "3" category of technical condition - not suitable for normal operation and need repair or replacement.
