### **2.1 Preservation and restoration of the wooden church, which is a spiritual, historical and cultural heritage**

We will consider the technical condition of the load-bearing structures of one of these churches using the example of the technical condition of the building of the wooden Church of Saint Michael the Archangel in the village of Stanislavchyk, Lviv region (Figures 1 and 2).

The purpose of the work: determination of the technical condition of the building of the wooden Church of Saint Michael the Archangel in the village of Stanislavchyk, Lviv region (hereinafter - the church).

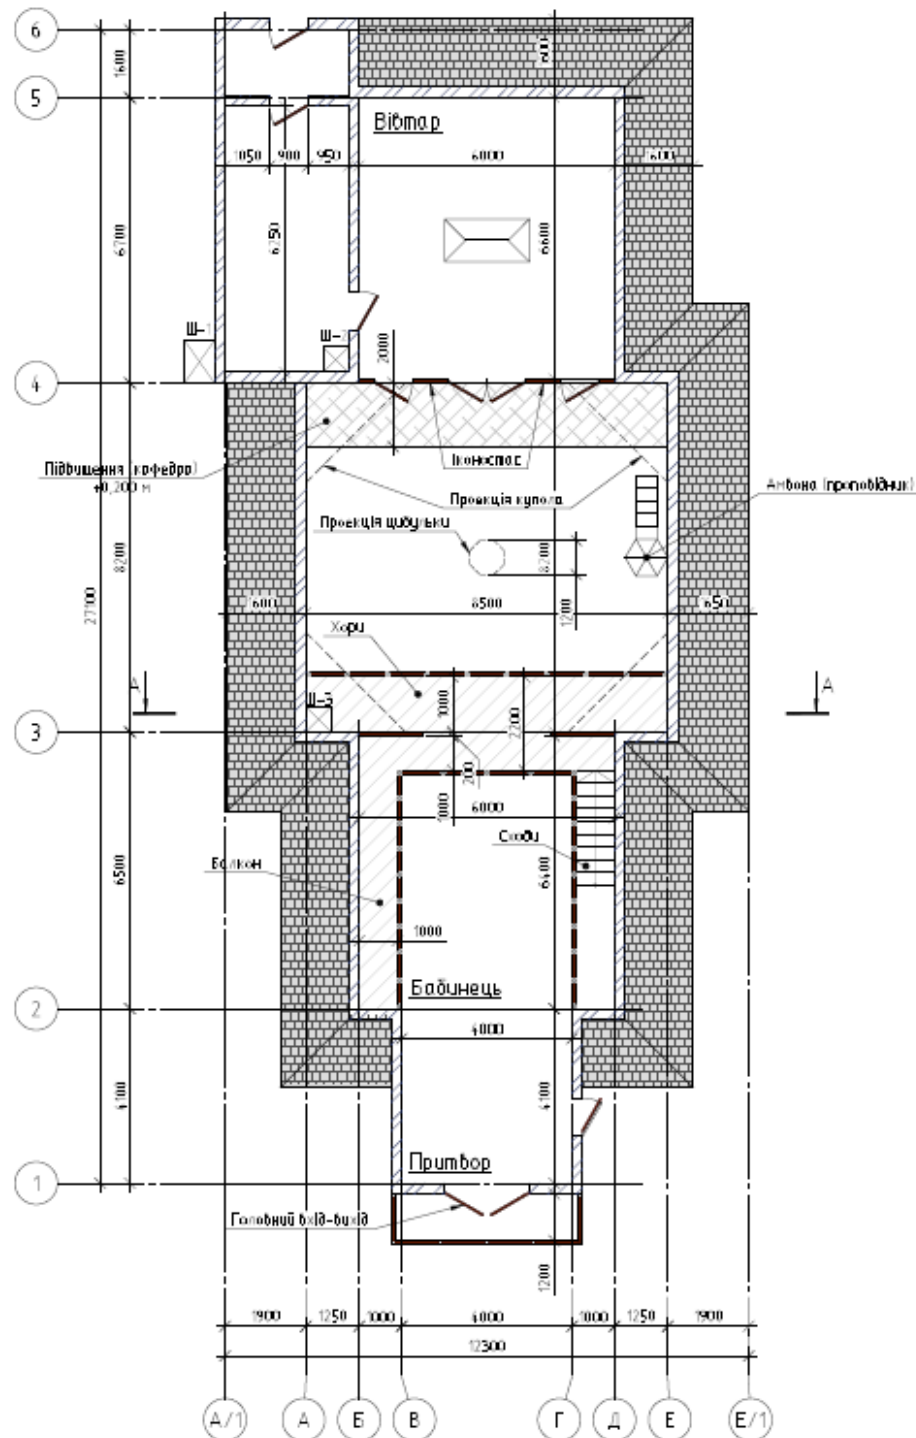
Figure 3. Plan of the church

In plan, the church contains an Altar with a throne measuring 6.00x6.60 m (in axes 4-5 and B-D) (Figure 3).

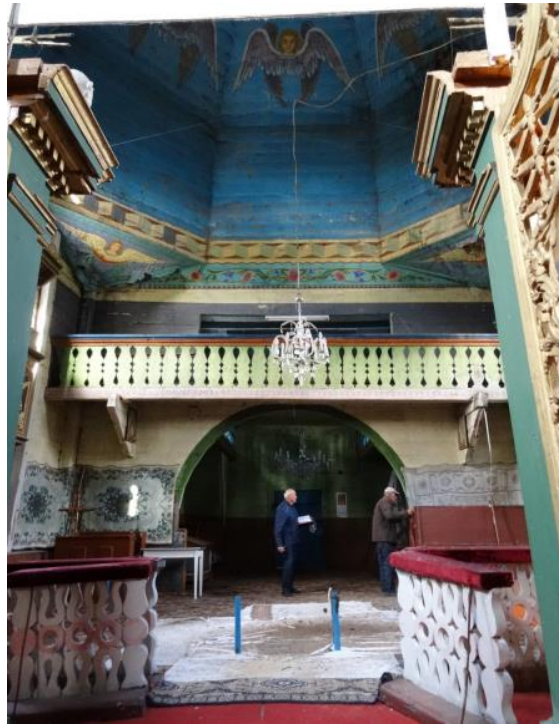
Figure 5. Photo of the church from the middle

and internal transverse walls, as well as a wooden pull placed on top of the choir floor (Figure 5).
