## SECTION 1. ARCHITECTURE, CONSTRUCTION

### 1.1 Investigation of metal silos structures to determine the cause of their destruction

The silos to be inspected are located on the territory of the complex of the grain-receiving enterprise in the Khmelnytskyi region. Nine silos are located in a cascade and are connected to each other in a common technological process by galleries above the silos (Fig. 1, 2, 3). Each silo is 27,4 m in diameter, the wall height is 18,7 m, the total height with the dome cover is 27 m.

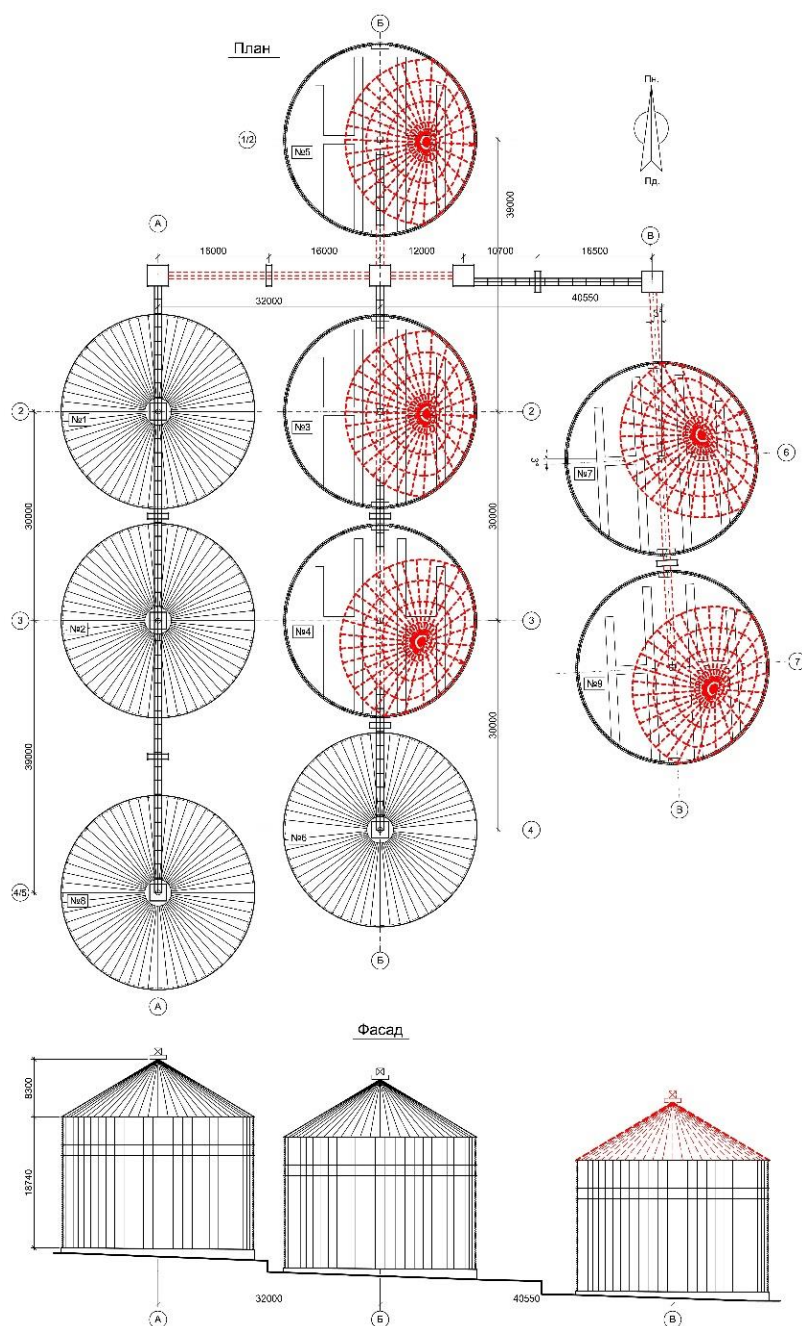
Figure 3. Layout of silos

At the time of the survey, five of the nine silos were destroyed (Figs. 2, 3). Their numbers in order of destruction: #9, #7, #5, #3, #4.
